Inle Lake Post-Disaster Environmental Assessment and Rehabilitation Plan

16th~30th September 2024 (Flood)

28th March 2025 (Earthquake)

Date of Report: May 2025

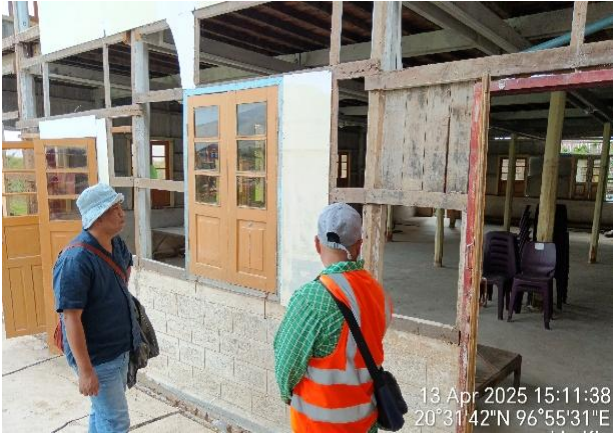
characterized by stilt houses built over soft, unstable ground, which contributed to the extensive structural damage observed. Many homes were either partially collapsed or rendered uninhabitable, forcing residents to take refuge in temporary shelters such as monasteries or community halls. The earthquake also disrupted essential services, including access to clean water, sanitation, and electricity, further deepening the humanitarian crisis. This field observation aimed to document these conditions and gather information to support recovery planning and future risk reduction efforts.

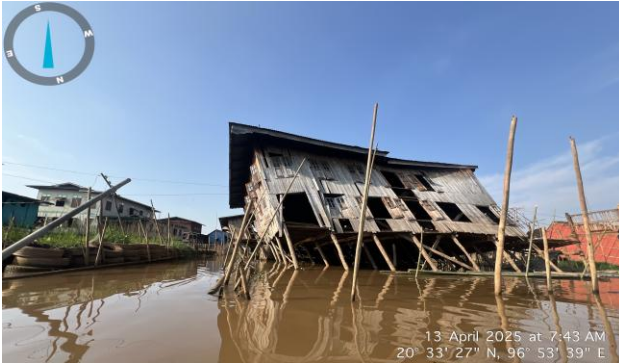
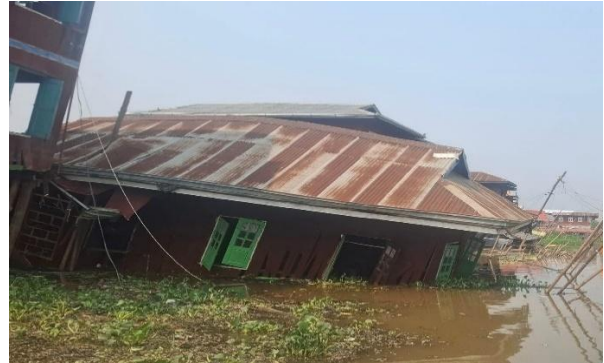
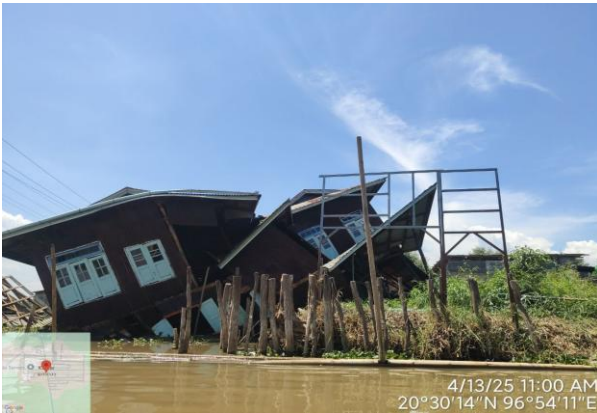
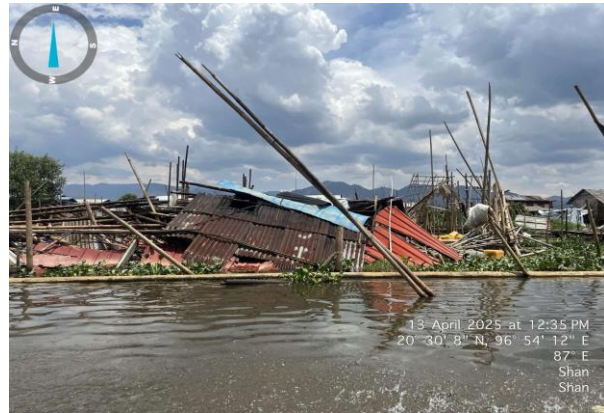
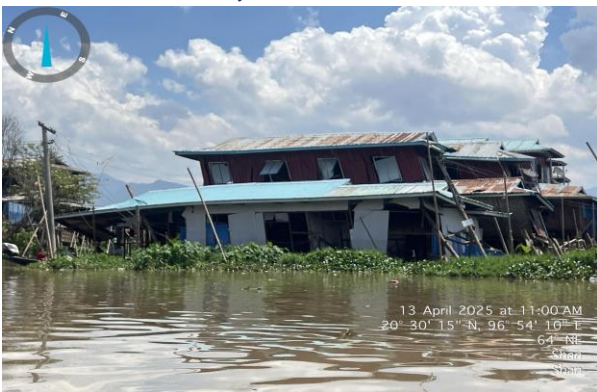
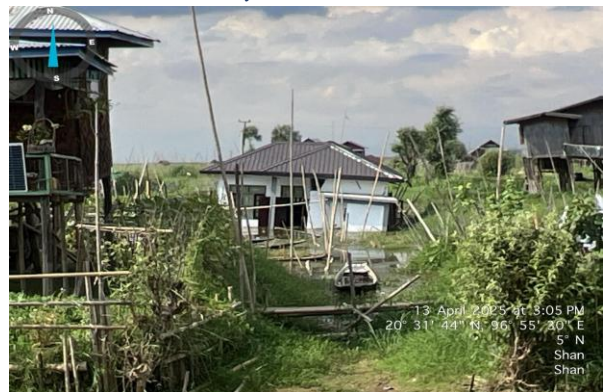
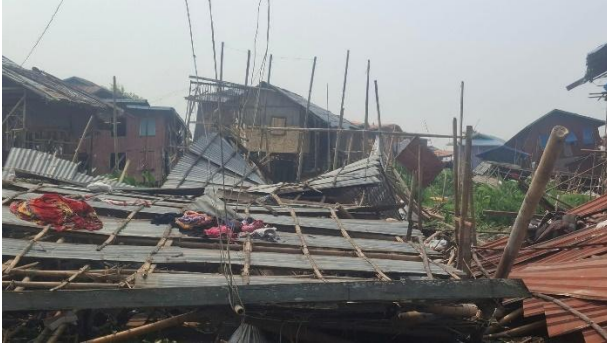
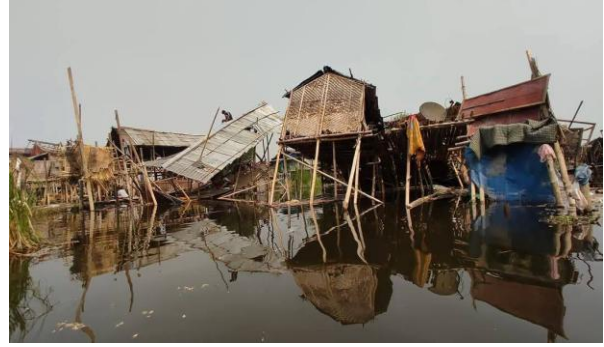
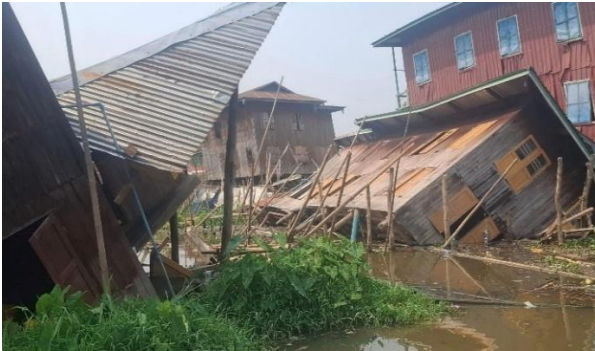
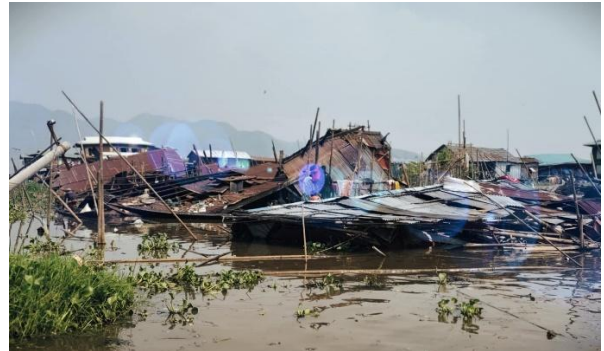
Figure 3-4 Household and Residential Structures Damage

Ward/Village Tract	House		Number of Affected Persons				
	Collapsed	Partially	Number of House	Household	Male	Female	Total
17	2297	595	2892	2903	6568	6815	13383

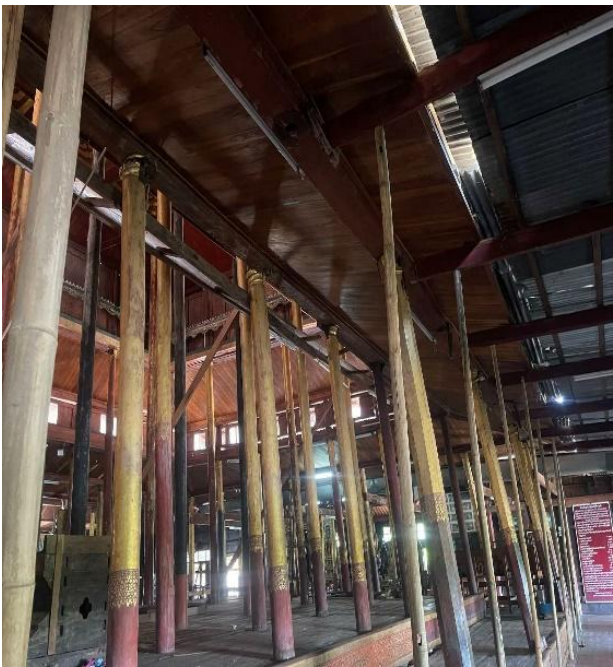
One culturally significant monastery, Nga Hpe Chaung Monastery, also known as the *Jumping Cat Monetary* “ကြောင်ခုန်ကျောင်း” which is over history spanning over 180 years, is constructed in the southern Shan traditional architectural style, containing rare ancient design features and numerous cultural artifacts. and previously reinforced with concrete footings due to aging, sustained severe damage including tilted support posts, cracked footings, fallen tie beams, and damage to religious sculptures while the monks’ dining hall fully collapsed.

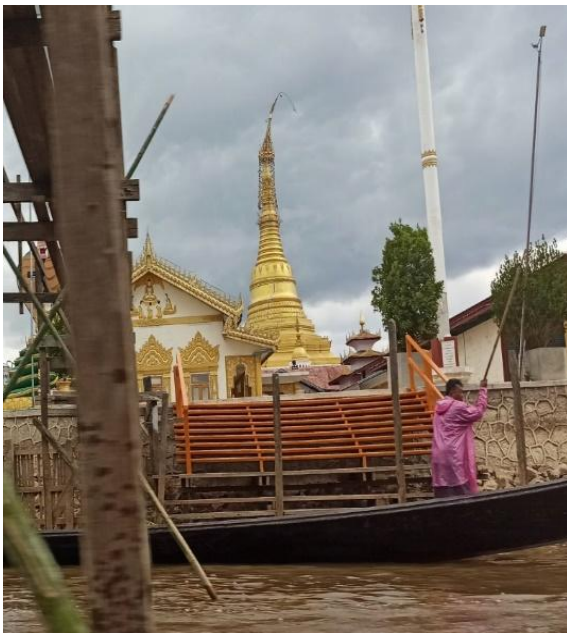
Ahlotaw Pauk Pagoda, located in Nampan Village, within Inle Lake, has tilted of its htee (umbrella finial), and some cracks have appeared in the lower base of the front platform.

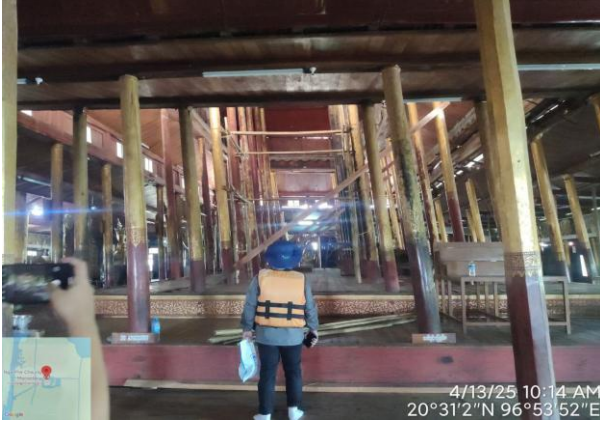
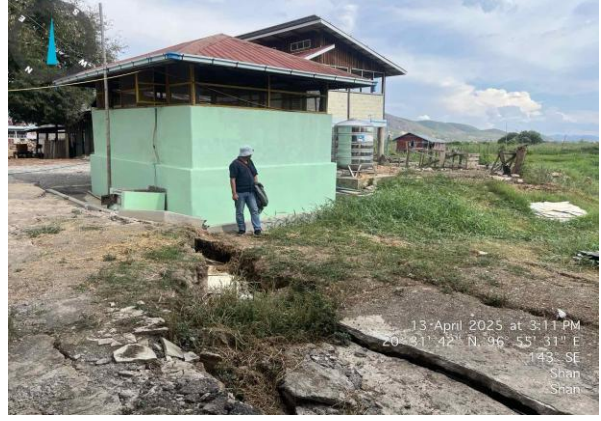
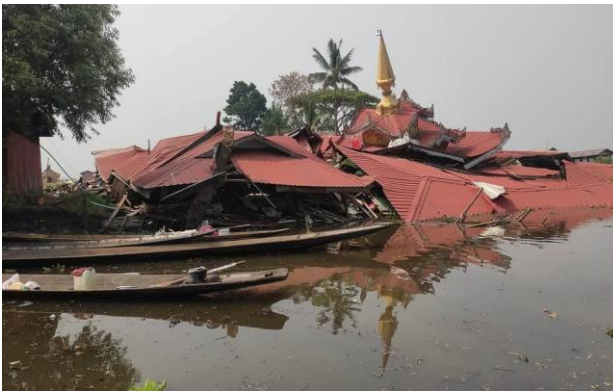
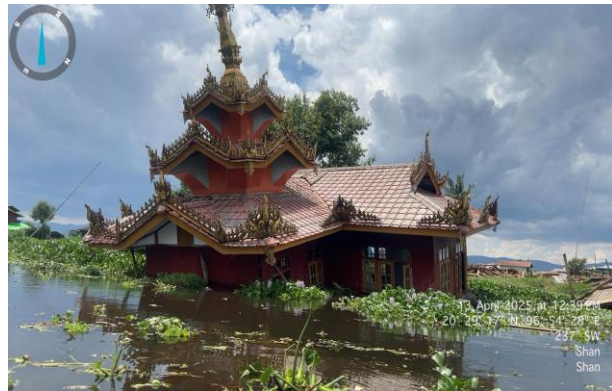
Figure 3-8 Damaged Religious Structures

Totally Damaged	Partially Damaged					Leaning		Brick Walls		Others
	Pagoda	Buddha Statue	Pagoda	Monastery	Pavilion and Adoration	Other Religious Schools	Pagoda	Monastery	Location	
5		11	33	4		4	25	5	1150	32

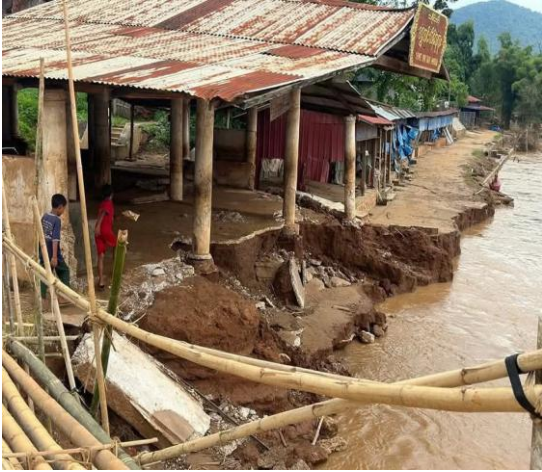
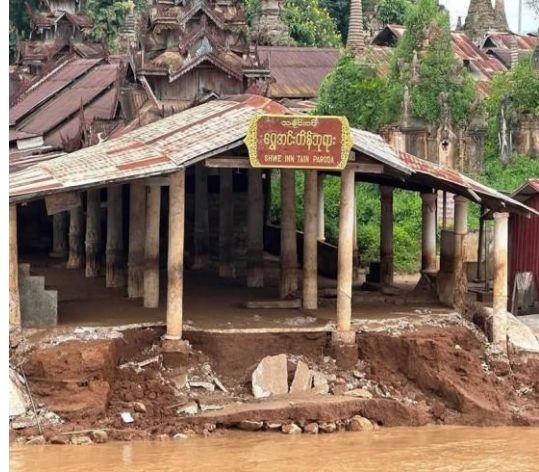
Historical inscriptions and carvings were washed away or heavily eroded and several Buddha statues suffered surface damage and material corrosion. Sacred relic chambers were breached in

at least 12 locations. It is reported that approximate 312 auxiliary pagodas were sustained partial or full structural collapse, 87 main pagodas reported cracks, foundation erosion, and brick disintegration and decorative elements and relic chambers were waterlogged and contaminated.

Figure 3-9 Buildings in the Inn Dein Pagoda Area that Collapsed due to Flooding

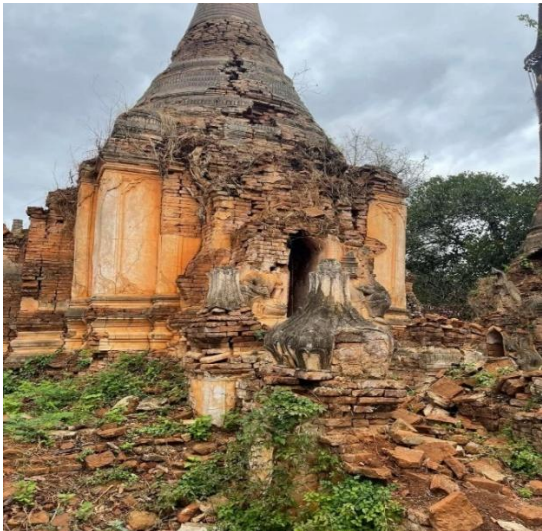
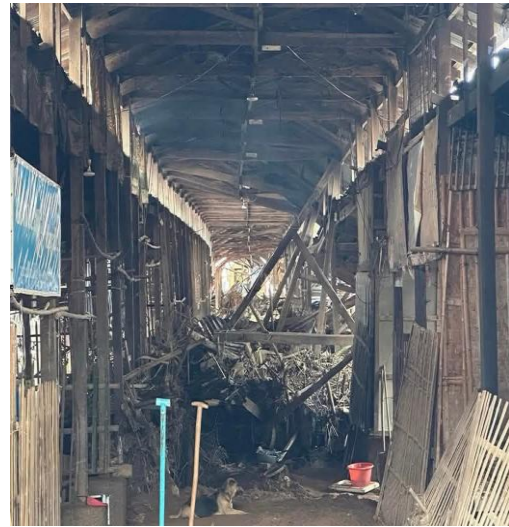
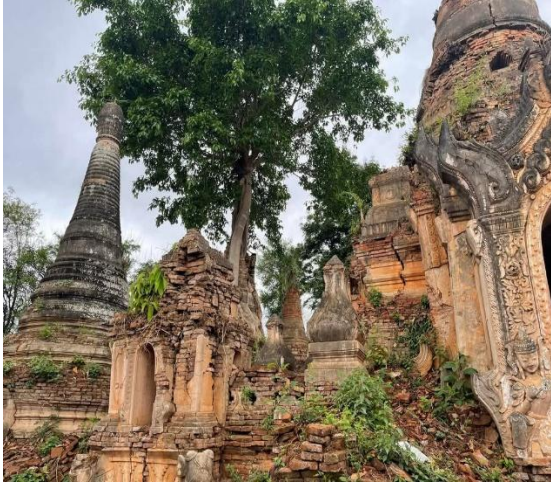
Figure 3-10 Temples Damage by Floods in the Inn Dein Area

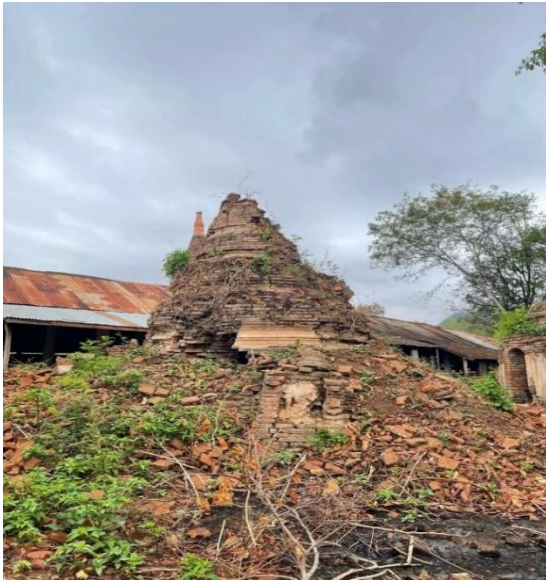
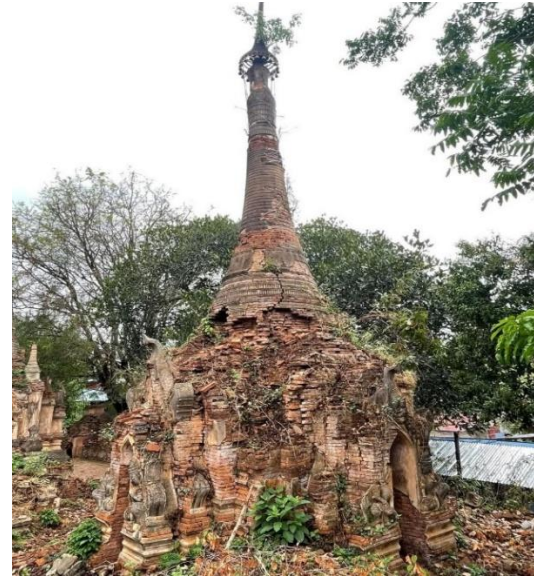
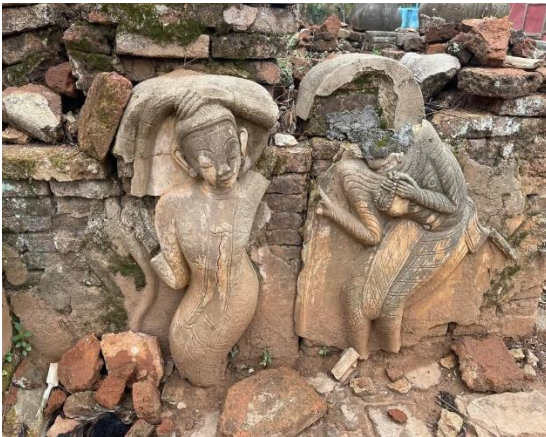
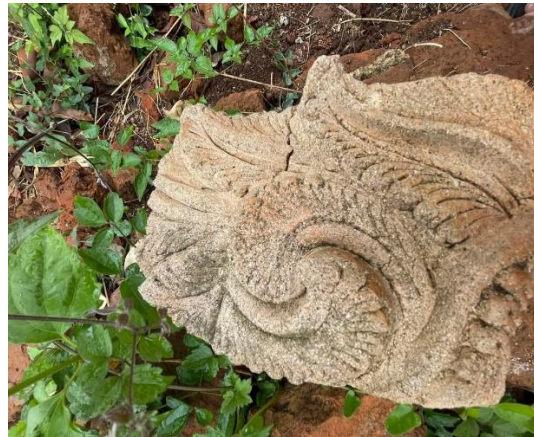
Figure 3-11 Stupas and Temples Damaged by Floods in the Inn Dein Area

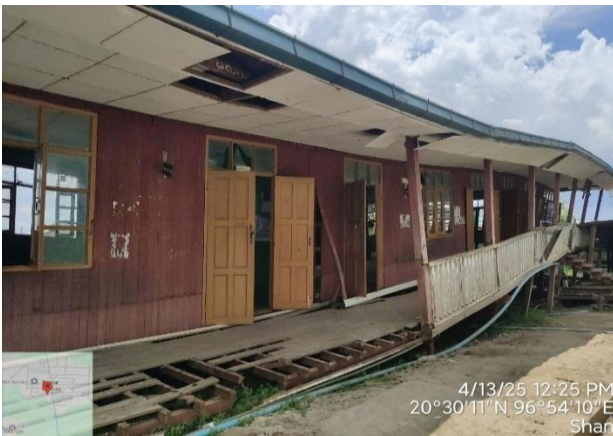
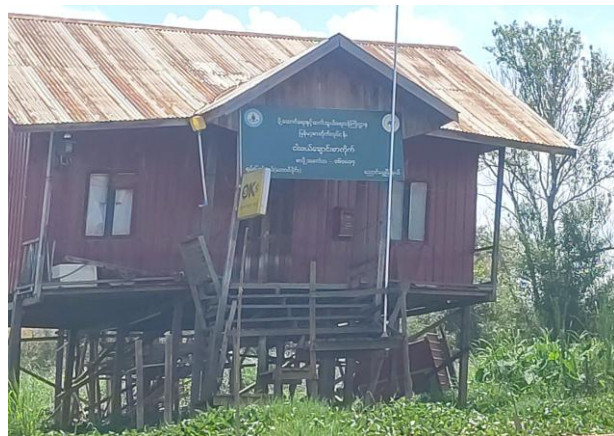
Figure 3-12 Damaged School

Total Number of Schools/ Offices	Education Officer's Office		Classroom Building		Staff Housing		Brick Walls		Others	
	Totally Damaged	Partially	Totally Damaged	Partially Damaged	Totally Damaged	Partially Damaged	Location	Feet	Totally Damaged	Partially Damaged
51		2	26	35		1	10	3314	198

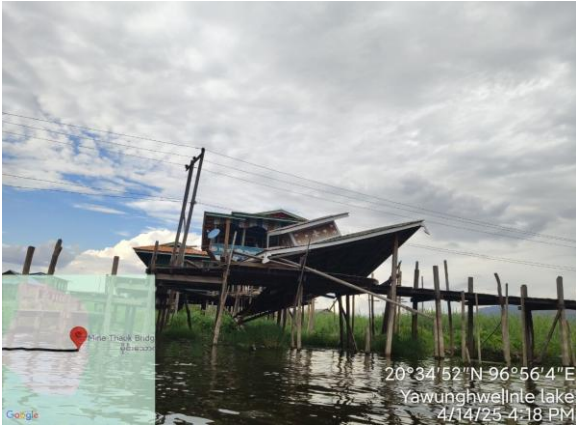
The earthquake affected nearby villages, where several small bridges showed signs of tilting and structural weakness. However, some villages experienced minimal damage, with key infrastructure such as roads and bridges remaining intact, reflecting relative resilience. Although the main bridge in Maing Thauk remained intact, numerous secondary routes and footpaths sustained severe damage, limiting access and complicating relief and recovery efforts. A subsequent aftershock later that day further intensified the situation. At Nga Phe Chaung Monastery, cracks developed in the retaining wall near the jetty. These incidents underscore the vulnerability of transportation infrastructure to seismic events, highlighting the need for structural assessments, stabilization measures, and long-term restoration planning.

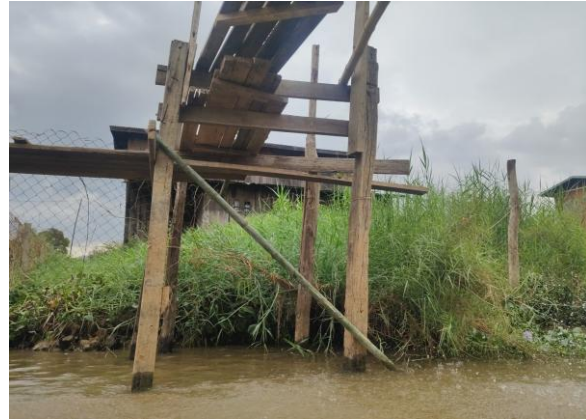
Figure 3-13 Damages to Transportation Infrastructures

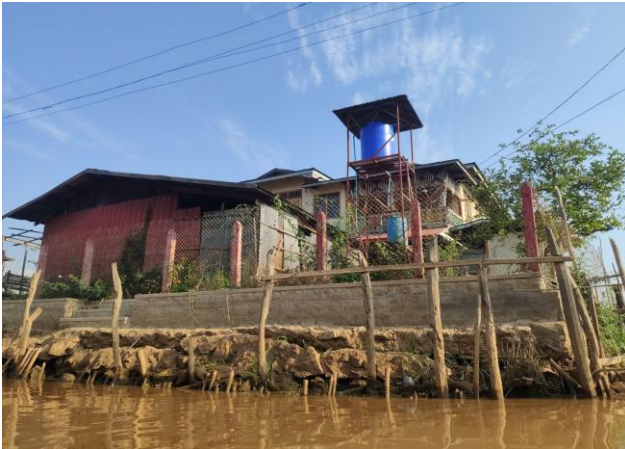
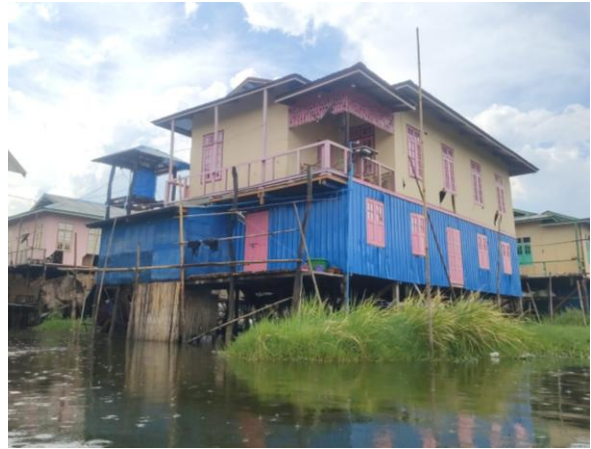
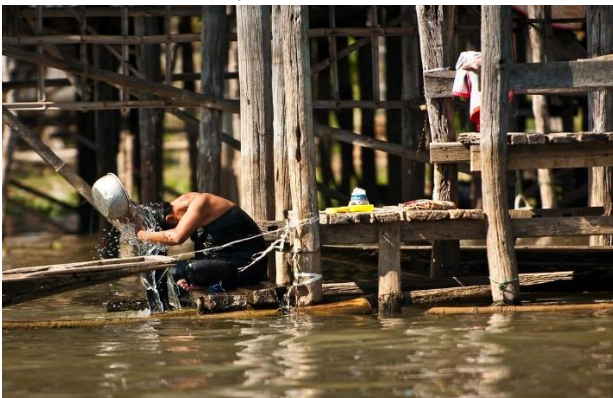
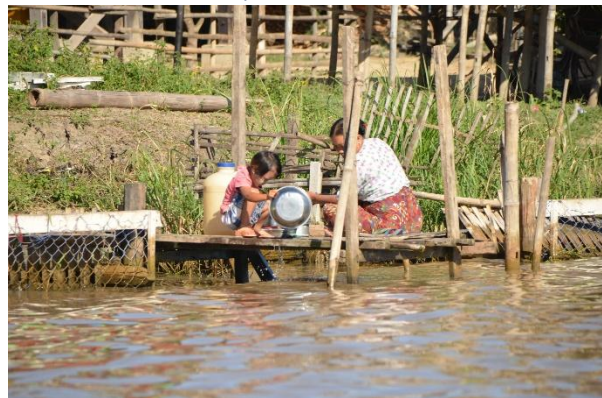
Figure 3-14 Current Domestic Water Usage

The recent earthquake and earlier flooding have exacerbated the situation by disturbing the lakebed and spreading accumulated pollutants, making the water unsafe even for basic non-potable uses. This disruption has sharply increased the risk of waterborne diseases such as diarrhea, skin

infections, and other hygiene-related illnesses. Although a few purification systems remain operational, their limited capacity cannot meet the heightened demand, leading to overcrowding and social tensions within communities particularly in densely populated areas. at water collection points and rising tensions in more populated areas.

Emergency water trucking has been introduced in some locations, but its reach remains inconsistent and unsustainable in the long term due to logistical challenges and damaged road infrastructure. There is an urgent need for comprehensive water quality testing, and the rehabilitation or expansion of existing systems. These interventions are critical to restoring safe and equitable access to water across all affected villages. Without swift and coordinated action, the ongoing water crisis may escalate into a secondary public health emergency and seriously hinder overall recovery efforts in the Inle Lake region.

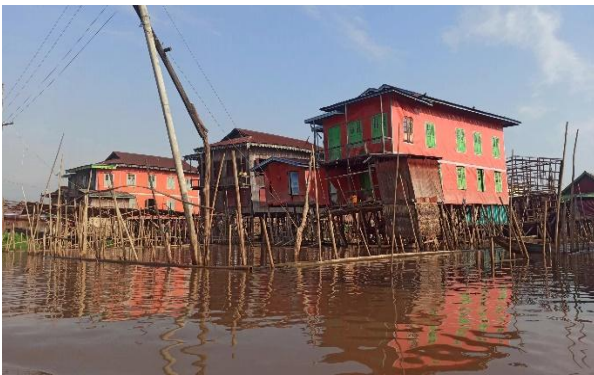
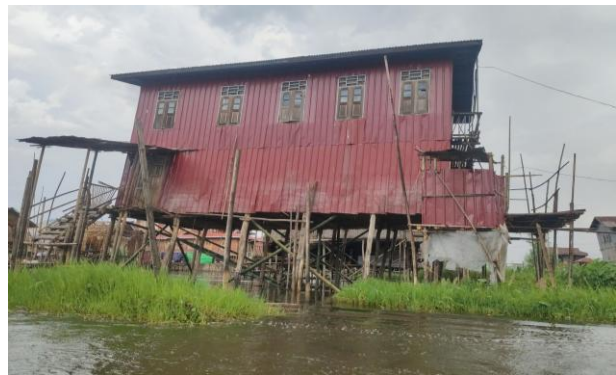
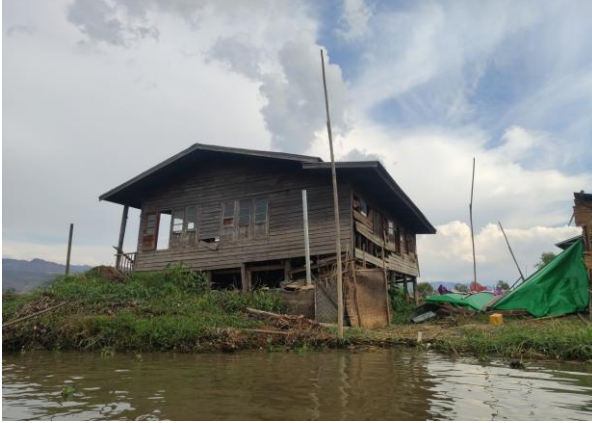
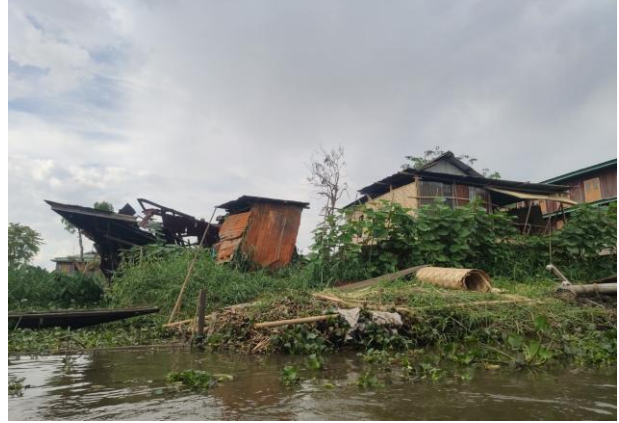
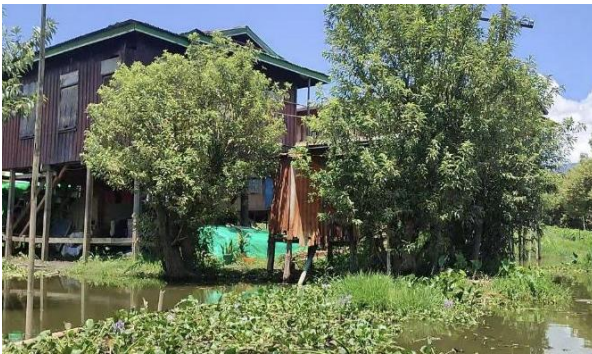
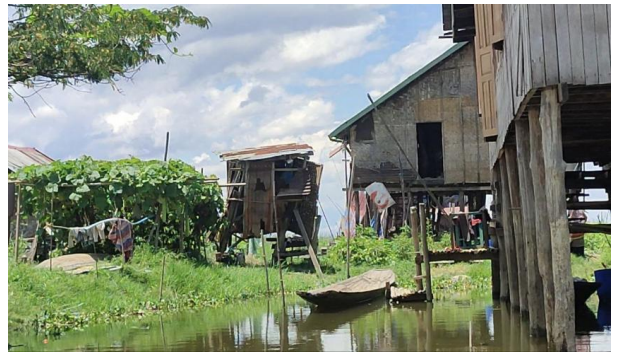
Figure 3-15 Current Sanitation Systems

Sanitation infrastructure in the region is basic and varies by housing location. Inland households generally use shallow, stone-lined pit latrines (around 4 feet deep), while stilt houses over the lake often discharge human waste directly into the water, a practice that has long contributed to the lake contamination. The recent earthquake and previous flood caused widespread damage to both inland and floating sanitation systems. Due to the instability or destruction of stilt housing caused by the disaster, the sanitation system was also damaged along with the houses, resulting in uncontrolled waste discharge into the lake, which poses significant risks to public health and further degrading the lake's ecosystem.

This has worsened pre-existing sanitation challenges. With many latrines rendered unusable, households have increasingly resorted to open defecation, especially in areas lacking alternatives. As a result, exposure to fecal matter has intensified, increasing the risk of waterborne diseases such as cholera, diarrhea, and intestinal parasites. The lake, which serves as a primary water source for most residents, is now further contaminated, undermining recovery efforts in water supply and hygiene.

Overcrowded temporary shelters and displacement sites often lack sufficient sanitation facilities, compounding the crisis. Immediate action is needed to provide emergency sanitation support, including safe temporary latrines, desludging services, and hygiene promotion. In the medium to long term, efforts should prioritize rehabilitating damaged systems and developing resilient, environmentally sound sanitation solutions to prevent future contamination and safeguard public health.

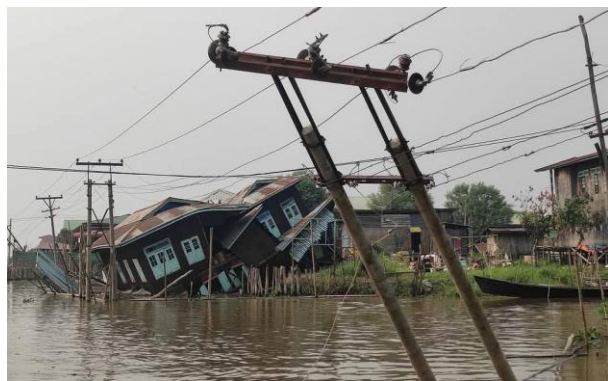
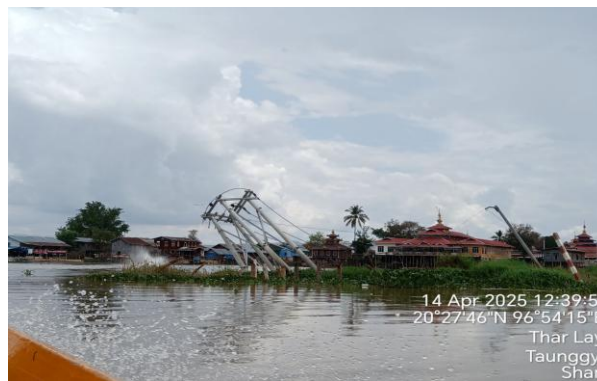
Figure 3-16 Damage to Electricity Supply Systems

Electricity in the region is primarily provided by the national grid, with some households relying on solar panels as a supplementary or alternative source. Although the earthquake did not cause uniform damage to electrical infrastructure across all villages, it led to the collapse of numerous electricity poles and localized failures of transmission lines. These damages triggered widespread power outages, even in areas where infrastructure appeared structurally intact, due to the interconnected nature of the grid.

In the short term, there is an urgent need to restore electricity through temporary power solutions such as mobile generators, solar-powered systems, and the rapid repair of damaged poles and lines. In the medium to long term, investments should focus on strengthening the resilience of the power infrastructure by decentralizing supply, expanding solar energy access, and reinforcing the grid to withstand future shocks. Enhancing energy reliability is essential not only for recovery but also for long-term development and disaster preparedness.

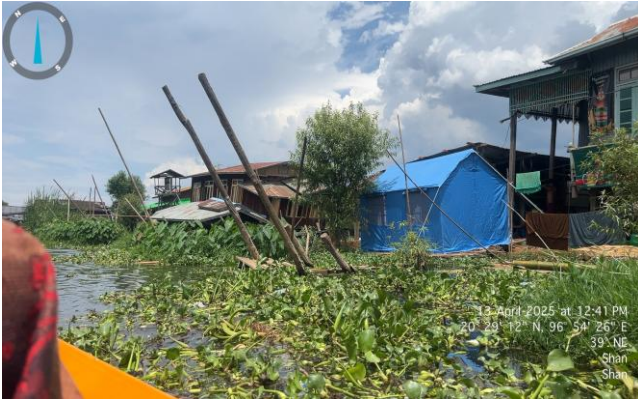
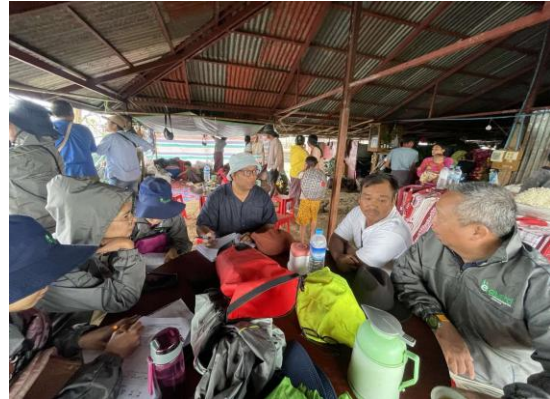
Figure 3-21 Temporary Shelters

The recent earthquake has caused widespread destruction to residential structures through partial or complete collapse, resulting in the displacement of hundreds of families in the Inle Lake region. Traditional homes especially those constructed with wood, bamboo, and thatched materials were particularly vulnerable, leading to extensive structural damage and instability. In addition to the immediate displacement, many homes have sustained damage that renders them unsafe for habitation, even if not entirely destroyed. This has left families in a state of uncertainty, unable to return or rebuild without proper technical assessments and resources.

To address these challenges, immediate actions must include rapid housing damage assessments, the establishment of well-planned temporary shelters, and the initiation of long-term housing recovery programs. These steps are essential to restoring stability, ensuring dignity for displaced populations, and enabling safe, voluntary returns to their communities.

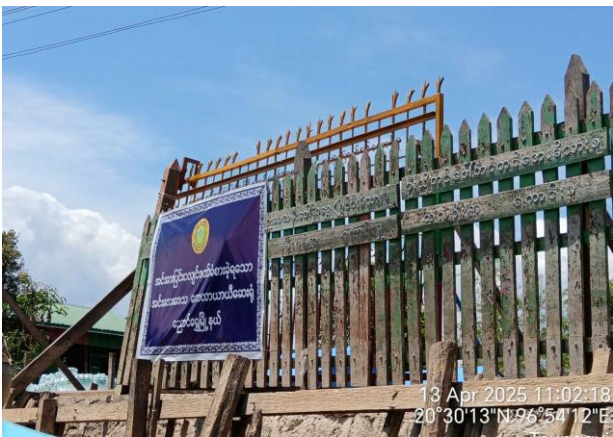
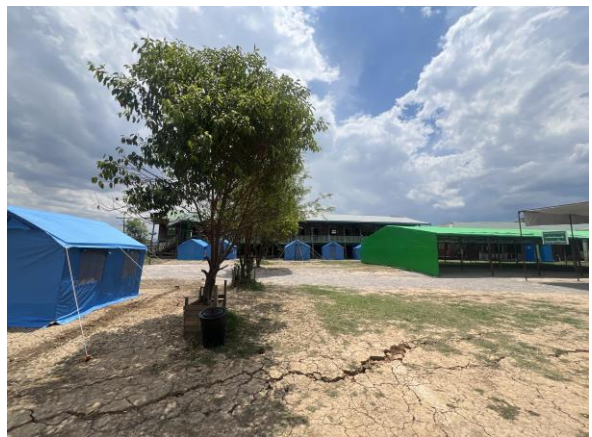
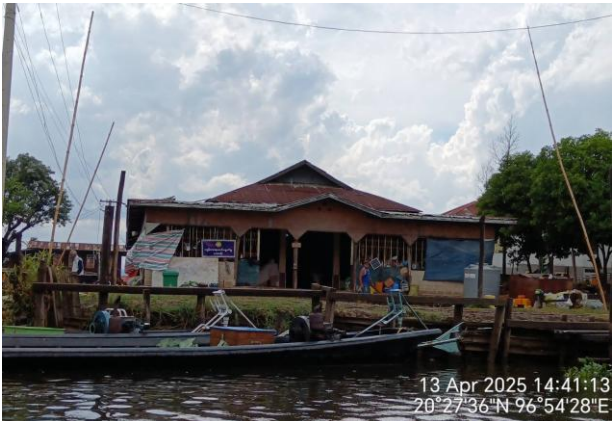
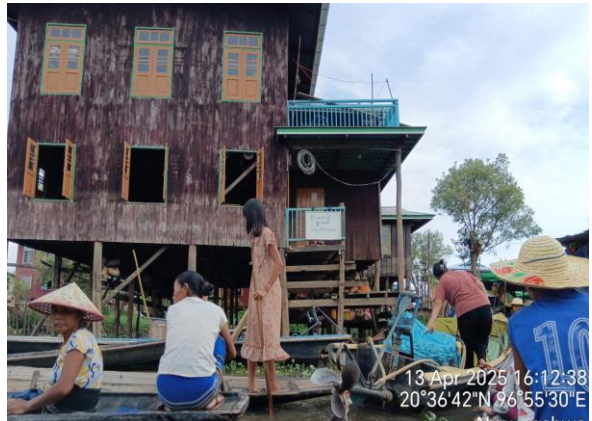
Figure 3-22 Temporary Relief Camp

The aftermath of the earthquake in the Inle Lake region has created serious public health concerns, particularly for displaced communities living in overcrowded and poorly equipped temporary shelters. Contaminated water sources and inadequate sanitation have significantly heightened the risk of disease transmission, especially among vulnerable groups such as children, the elderly, pregnant women, and individuals with chronic health conditions.

Many displaced families are relying on untreated lake water for cooking, and washing due to limited access to clean water. This has led to a rise in waterborne illnesses, including diarrhea, dysentery, and potentially cholera posing a serious threat to public health. In addition, the absence of proper waste disposal systems and inadequate latrine facilities within temporary shelters contributes to unsanitary living conditions, increasing the risk of infection.

To prevent a public health crisis, immediate interventions are urgently needed. Priorities should include:

- Provision of safe and treated drinking water;
- Installation of emergency latrines and sanitation facilities;
- Distribution of hygiene kits and essential medicines;
- Implementation of nutrition support programs for vulnerable groups;
- Public awareness campaigns on disease prevention and hygiene practices.

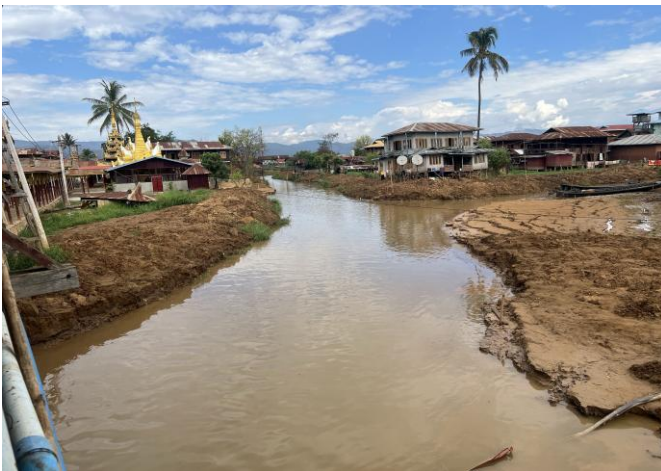
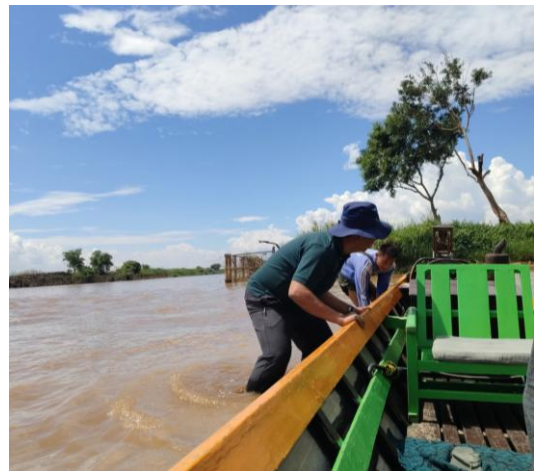
Figure 3-24 Current Conditions of Waterway at Inn Dein Creek

Environmentally, the sedimentation has altered the hydrological balance of the lake. Reduced water circulation has created localized stagnation, diminishing oxygen levels in the water and increasing the risk of algal blooms. Fish breeding areas, especially those in shallow and vegetated zones, have been smothered by silt, affecting reproductive cycles and reducing fish populations. Aquatic biodiversity is under pressure, as sensitive species struggle to adapt to changing water quality and habitat loss.

The long-term impacts of sedimentation could be severe if not addressed. Prolonged disruption of water flows may contribute to shrinking lake area, shoreline erosion, and further ecological imbalance. Moreover, the physical disconnection of water bodies through sediment-filled channels can fragment habitats and limit nutrient exchange between sections of the lake. Restoring waterway connectivity should therefore be a key priority in environmental recovery efforts. This will require a coordinated sediment dredging program, reforestation of degraded catchment areas to reduce future runoff, and the establishment of sediment traps or retention ponds to prevent further inflow of debris into critical lake areas. Involving local communities in monitoring and maintenance of the waterways can also enhance sustainability and ownership of restoration processes.

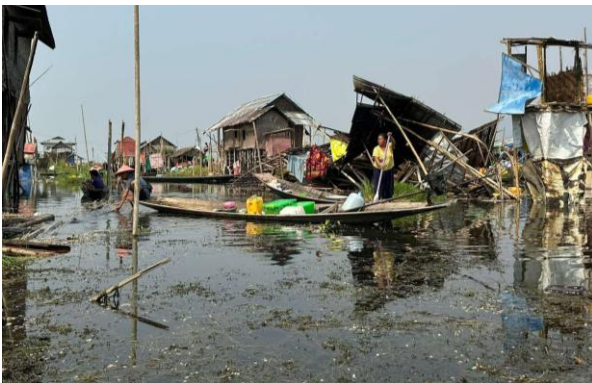
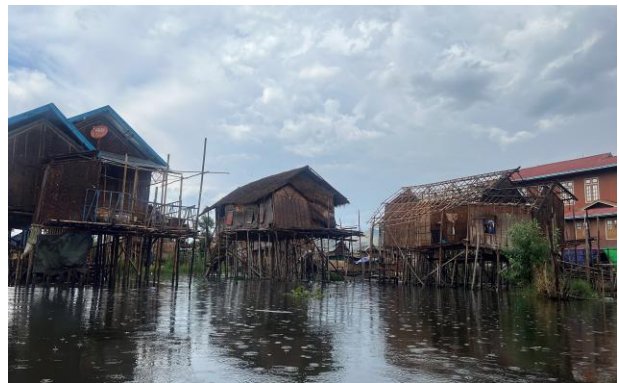
Figure 3-25 Current Condition of Water Quality in Inle Lake near Residential

The water quality of Inle Lake has sharply deteriorated in the aftermath of the recent earthquake, exacerbating the already stressed environmental conditions caused by previous flooding. The lake, which supports the livelihoods of thousands and serves as the primary source of water for domestic use, agriculture, and aquaculture, is now facing a serious pollution crisis. Large volumes of debris, decaying vegetation, and solid waste from damaged homes and infrastructure have entered the lake, accompanied by runoff containing fertilizers, pesticides, and other chemicals from surrounding agricultural plots.

One of the most concerning developments is the widespread discharge of untreated human waste directly into the lake. With many sanitation facilities damaged or destroyed by the earthquake, households and temporary shelters along the lake's edge have been forced to dispose of waste directly into the water. The collapse of pit latrines, toilets, and septic tanks has compounded the problem, resulting in the spread of pathogens and elevated levels of organic pollution. As a result, the lake exhibits visible signs of contamination, including greenish discoloration, strong odors, algal growth, and floating debris. These indicators signal deteriorating water quality, oxygen depletion, and a risk of eutrophication.

compared to the levels recorded before the event. Prior to the earthquake, turbidity values with a maximum of 385 NTU, with only a few locations exceeding the National Standards for Water Quality Guideline (NSWQG) Class V threshold of 100 NTU. However, after the earthquake, the turbidity levels escalated sharply, reaching up to 600 NTU in some monitoring sites. Multiple locations showed values well above the standard, such as 592 NTU and 249 NTU. This substantial rise in turbidity is likely attributed to sediment disruption, soil erosion, and increased runoff caused by seismic activity. The post-earthquake data clearly indicate a decline in water clarity, posing potential risks to aquatic ecosystems and water usability in the region.

To address this growing crisis, a coordinated and multi-pronged response is urgently needed. Temporary sanitation facilities should be installed to prevent further contamination, and urgent repairs to damaged sewage systems must be prioritized. In the medium to long term, investments should be directed toward the development of climate-resilient water and sanitation infrastructure, environmental monitoring systems, and public education campaigns on hygiene and safe water use. Rehabilitation of the lake's ecosystem through wetland restoration, biological filtration zones, and community-led waste management will be essential to restoring water quality and preserving the ecological integrity of Inle Lake for future generations.

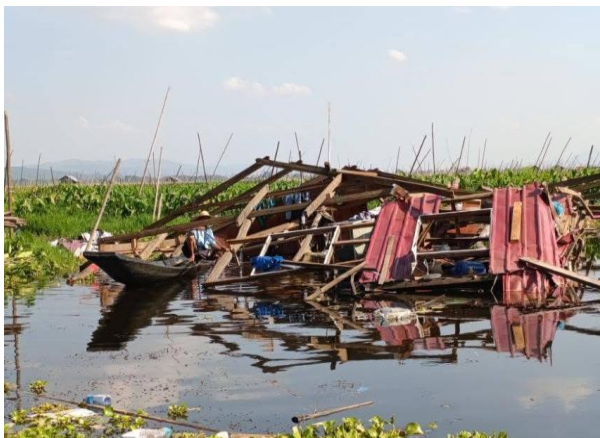
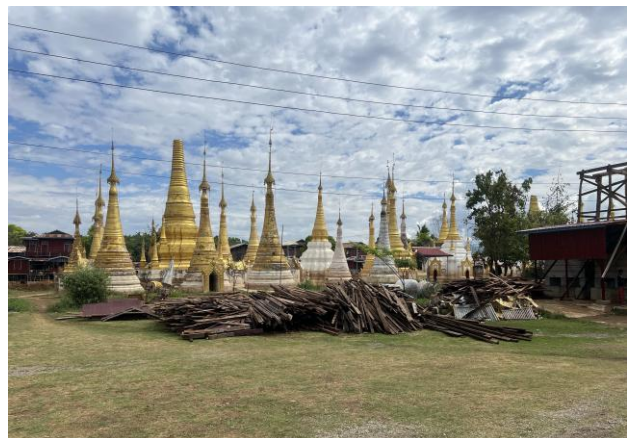
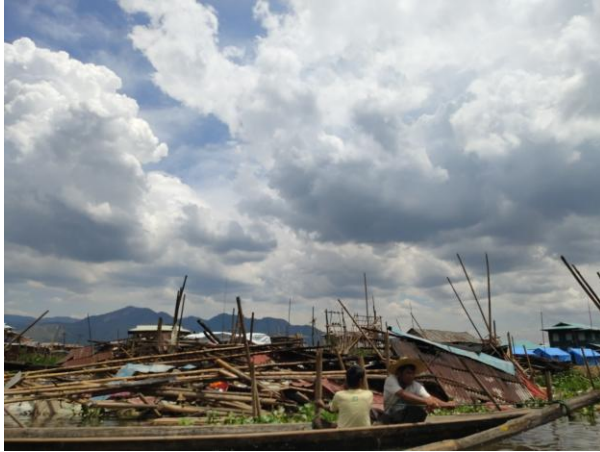
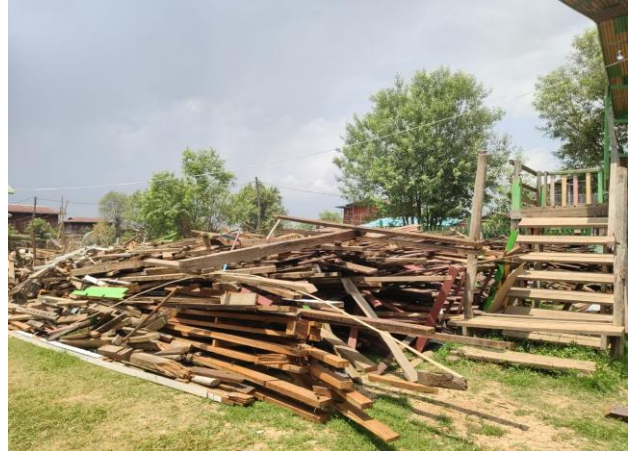
Figure 3-26 Demolition Waste

The earthquake in the Inle Lake region has generated large volumes of demolition debris, including materials from collapsed homes and public buildings such as wood, bamboo, tin sheets, roofing tiles, bricks, plastics, and broken household items. In many of the hardest-hit villages, this rubble remains scattered across residential areas, roads, public spaces, and lakeside walkways. The lack

The unmanaged waste poses multiple risks. Piles of debris obstruct movement and complicate access for emergency services, humanitarian aid, and reconstruction teams. In densely populated areas, it increases the risk of injuries, especially for children, elderly persons, and those navigating unstable ground. The materials also harbor insects and vermin, contributing to unhygienic conditions. In an attempt to deal with the waste, some residents have resorted to burning debris or dumping it in or near the lake and canals. These practices have led to further air and water pollution, contributing to the ongoing deterioration of water quality and placing additional strain on the already fragile environment.

Addressing this issue requires the urgent establishment of safe, systematic, and environmentally responsible demolition waste management mechanisms. Immediate actions should include the deployment of local cleanup teams, supported by municipal authorities or humanitarian actors, to remove debris from critical zones. Designated temporary waste collection and sorting sites must be established with clear protocols for hazardous materials and recyclable components. Community involvement will be key: awareness campaigns on safe disposal practices, combined with training for local waste handlers, can foster shared responsibility and ensure sustainability. In the long term, investing in localized waste recycling infrastructure, introducing green building materials, and incorporating disaster-resilient urban planning can help reduce the environmental footprint of future disasters and contribute to more sustainable reconstruction.

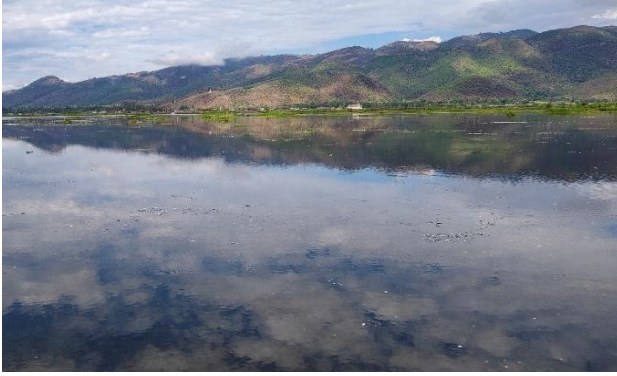
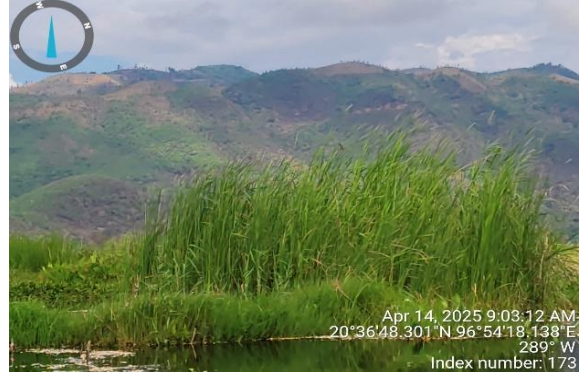
Figure 3-27 Land Cover Changes Due to Deforestation

Deforestation in the Inle catchment area has been a major driver of ecological decline. The removal of natural vegetation for agriculture, fuelwood, and settlements has reduced forest cover, exacerbating soil erosion and sedimentation in the lake.

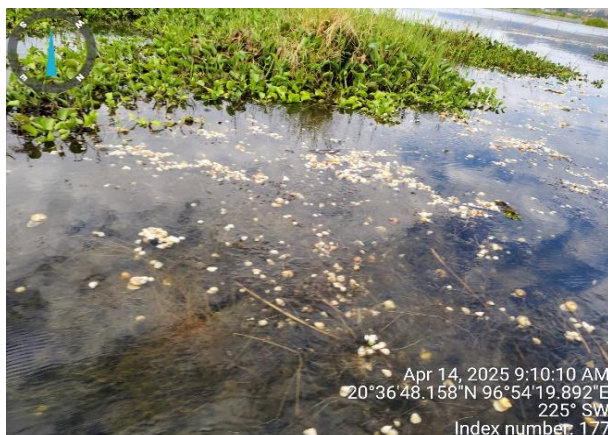
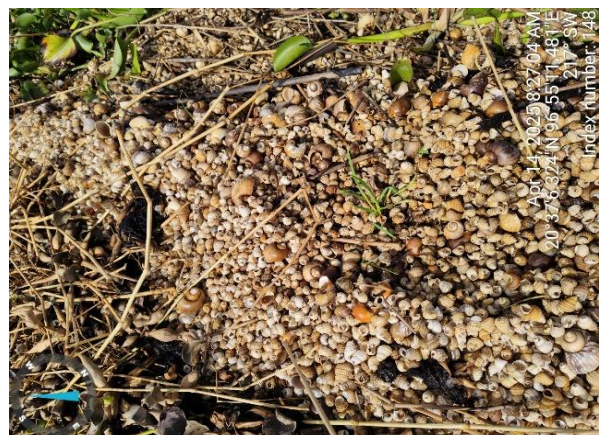
Figure 3-28 Eutrophication and the Mass of Death Snail Shell

Shifting cultivation and improper land-use practices have intensified soil erosion, particularly in sloping areas. The eroded sediments flow into the lake, increasing siltation and reducing water depth, which disrupts aquatic vegetation and fish breeding grounds.

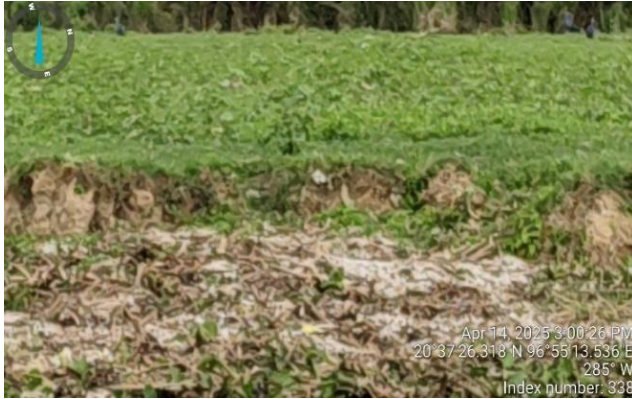
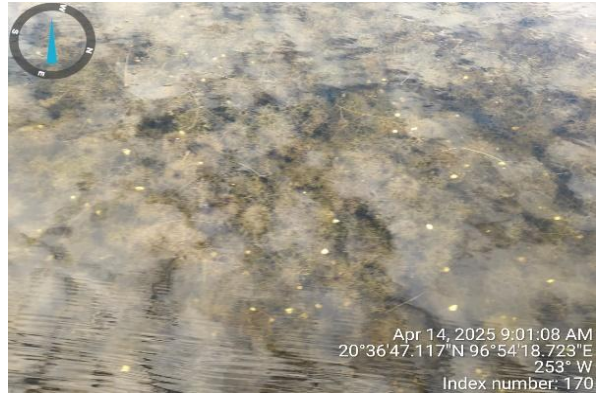
Figure 3-29 Erosion and Eutrophication

Earthquakes may alter the lake's topography, destroying nesting and breeding sites for birds and fish. Flooding can submerge wetlands, displacing species that rely on these ecosystems for survival.

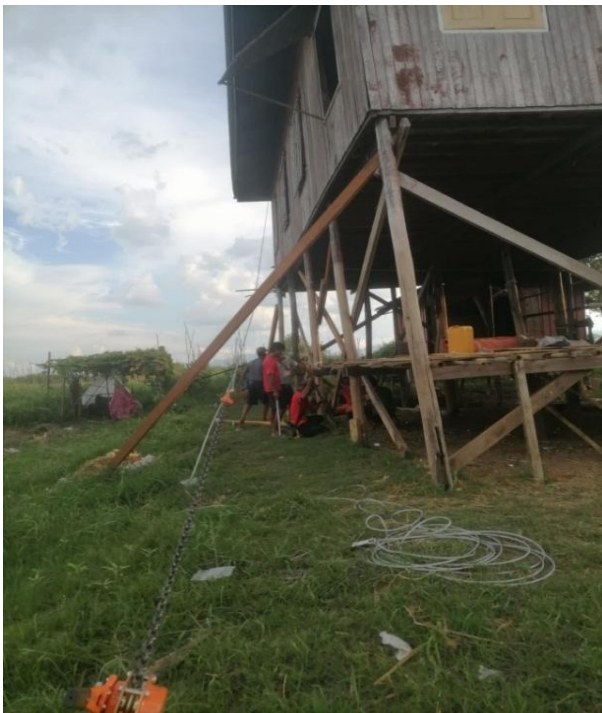
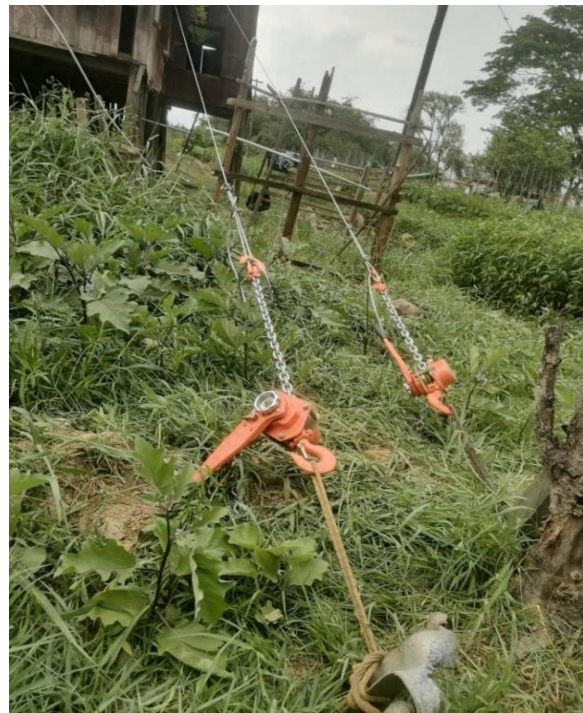
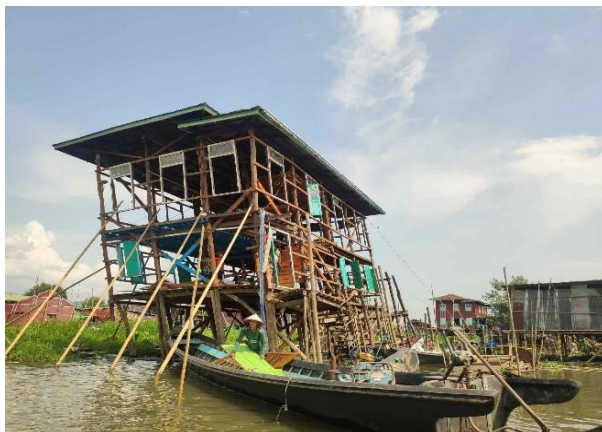
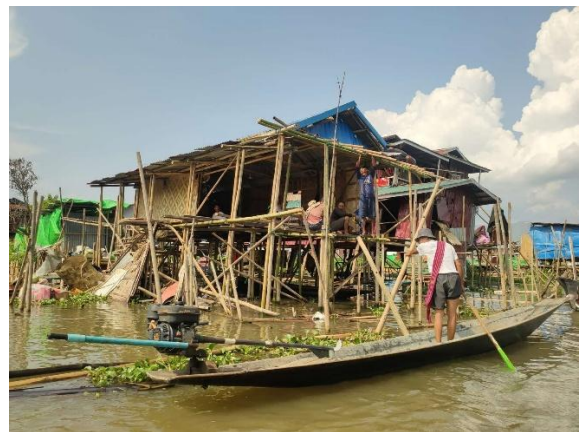
Figure 4-1 Tiled Traditional Style Stilt Timber Houses under Restoration Work

In cases of tilted and distorted houses and buildings constructed on timber pile foundations, some structures may be temporarily stabilized by erecting with the aid of counterweights or additional loads. However, most of them cannot be effectively restored using this method. This is primarily due to the loss or reduction of the timber piles' bearing capacity, caused by dynamic external forces such as ground shaking during earthquakes and fluctuations of water levels during unusual flood events. In particular, large-scale buildings like monasteries are especially difficult to stabilize through load adjustments alone. Their foundations are more vulnerable due to not only dynamic loading but also the cumulative effects associated with group pile behavior, leading to a gradual loss of bearing capacity during disaster events.
