Inle Lake Post-Disaster Environmental Assessment and Rehabilitation Plan

16th~30th September 2024 (Flood)

28th March 2025 (Earthquake)

Date of Report: May 2025

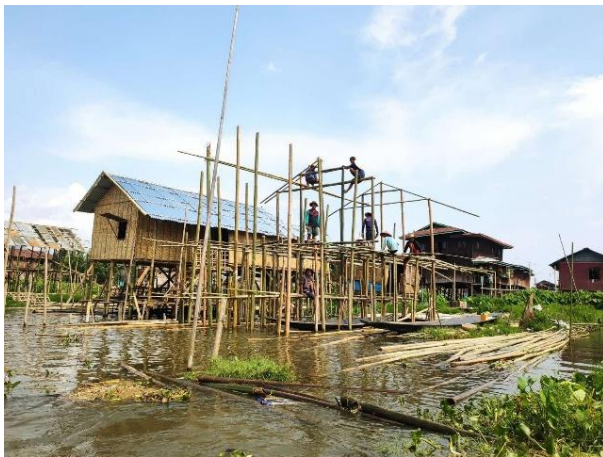
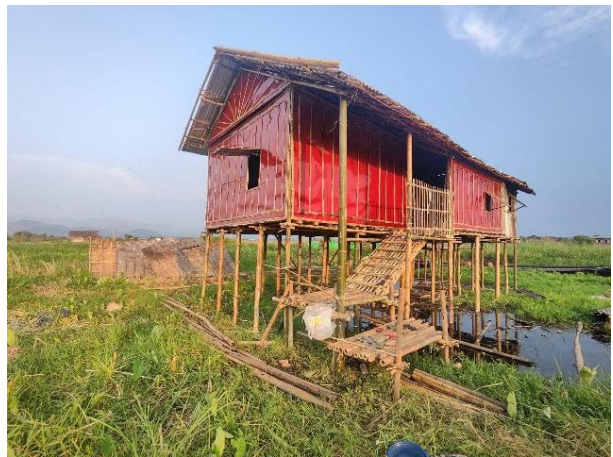
Figure 4-2 Donor’s Funded Stilt House Newly Built in Place of Collapsed One on Lake Water

A central priority is the reconstruction of disaster-resilient housing. Many traditional stilted houses, floating homes, and community structures collapsed or were irreparably damaged during the flood and earthquake, either due to direct impact or because they had been weakened over time by poor construction practices and environmental stressors. Rebuilding must go beyond replacing what was lost. New housing should be designed to withstand future floods, seismic events, and strong winds, incorporating elevation benchmarks based on historical and recent maximum flood levels. Technical guidelines, design standards, and community training in resilient construction practices must be urgently developed and disseminated. Incentive-based support schemes should be introduced to assist low-income households in upgrading their homes to meet these new standards.

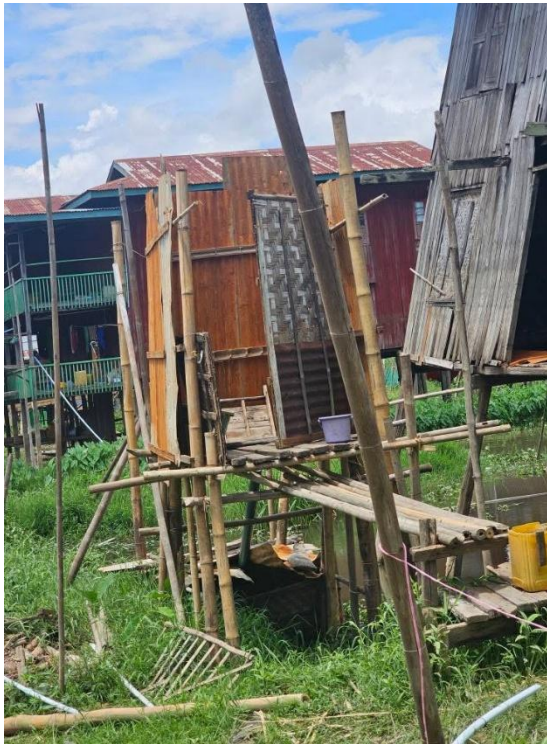
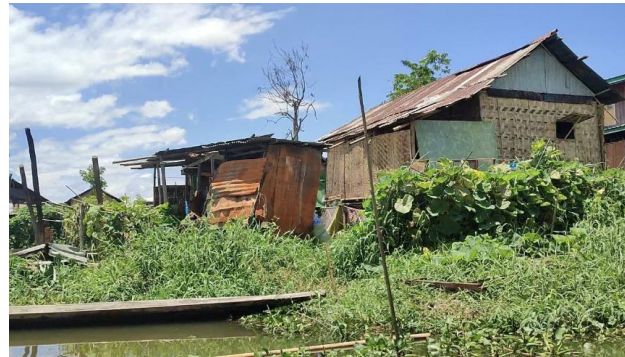
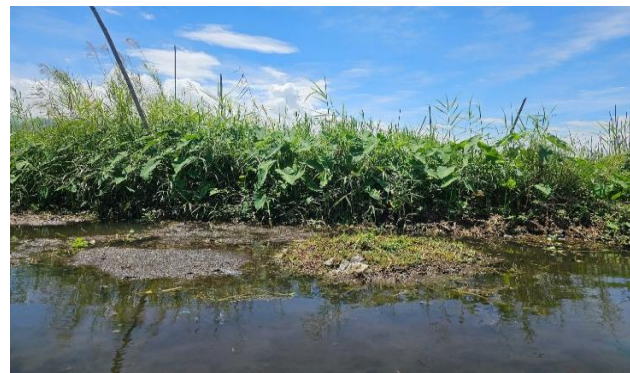
Figure 4-3 Latrine Waste in contact with Lake Water and Floated Raw Sewage Deposit from Direct Disposal

Water and sanitation systems must also be urgently restored and upgraded. The earthquake ruptured many existing latrines, while floodwaters contaminated open wells and surface water sources. This has severely impacted public health and access to safe drinking water. Reconstruction should prioritize decentralized, climate-resilient water and sanitation system such as rainwater harvesting systems, and sealed septic systems. All sanitation infrastructure must be designed to prevent the release of untreated waste into the lake, supported by clear regulations, monitoring systems, and community engagement in waste management practices.

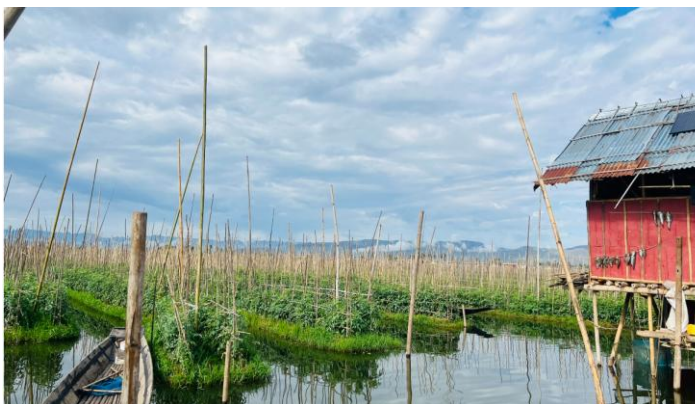
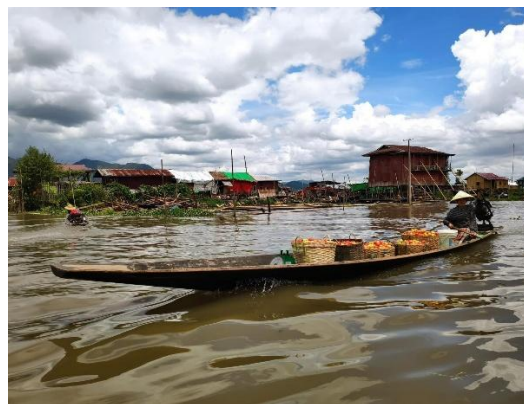
Figure 4-4 Floating Garden and Local Transport

The rehabilitation of the local transportation network, including water-based mobility systems, is equally essential. Many piers, floating walkways, and mooring stations were damaged or destroyed, disrupting livelihoods dependent on lake transport. Reconstruction efforts should improve the durability of these structures while also regulating the use of motorboats to reduce environmental pollution. The drainage system is another important factor for infrastructure resilient during multiple natural disasters.

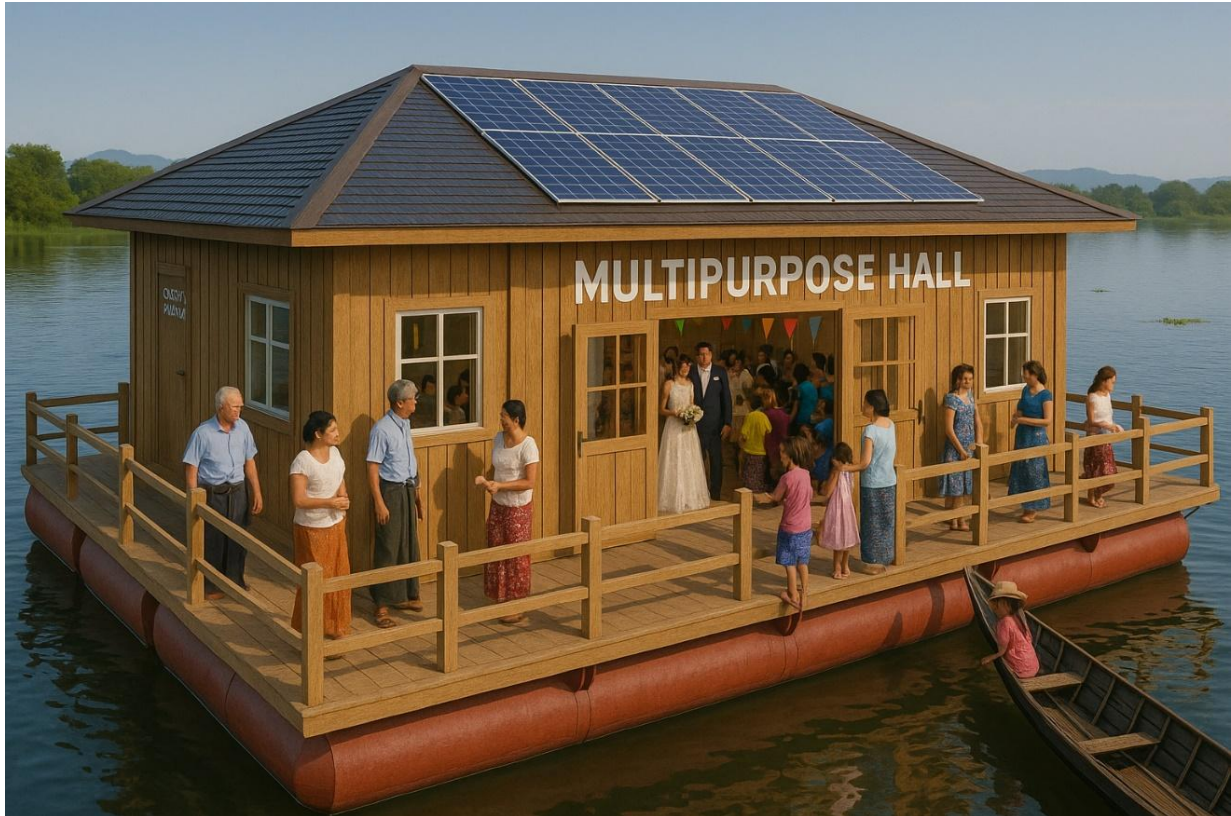
ရေပေါ်ကယ်ဆယ်ရေးဆောင် နမူနာ (ရပ်ရွာ အခမ်းအနားပွဲတွင် အသုံးပြုစဉ်)

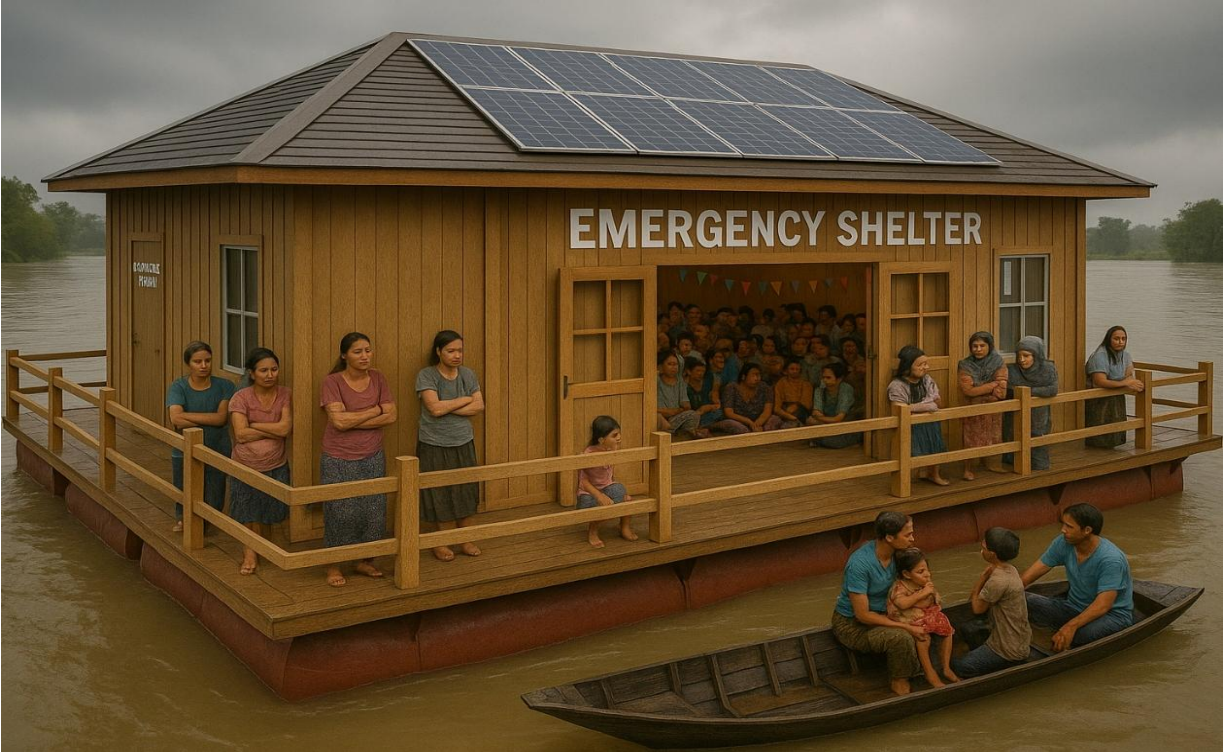
ရေပေါ်ကယ်ဆယ်ရေးဆောင် နမူနာ (ရေကြီးချိန်တွင် အသုံးပြုစဉ်)

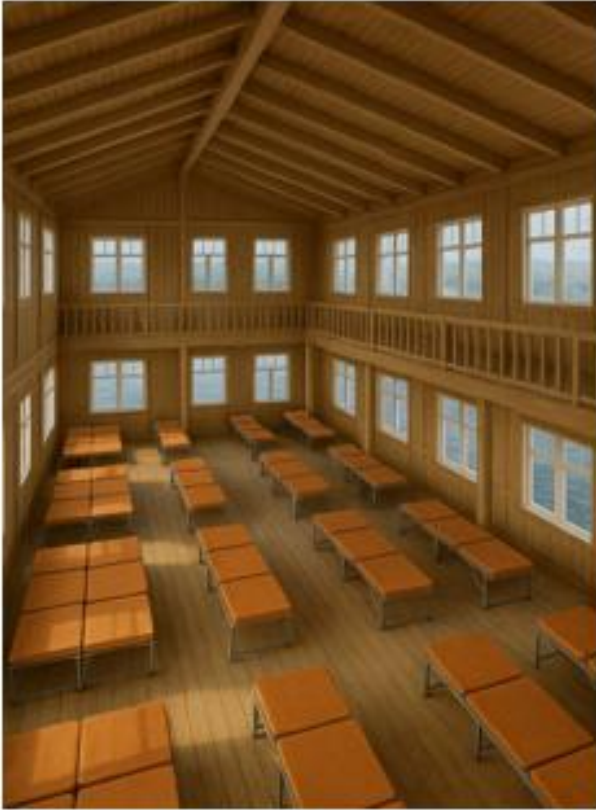
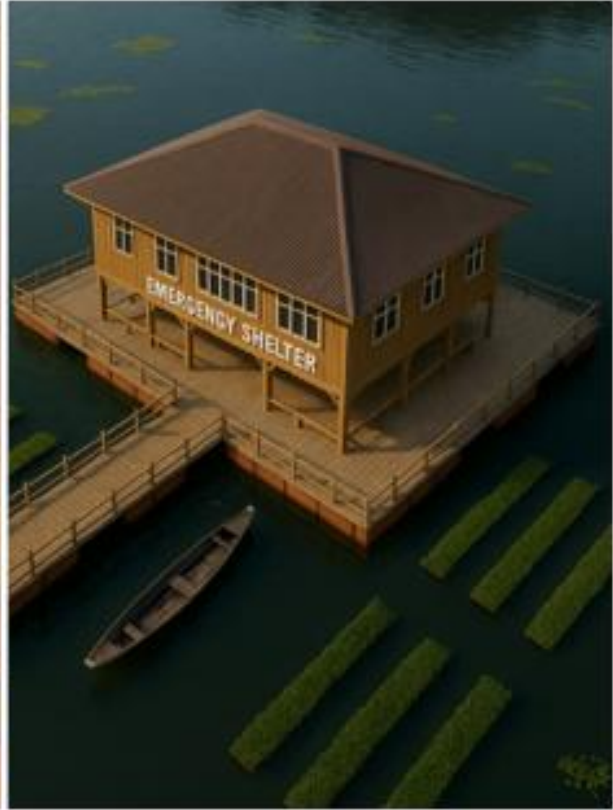
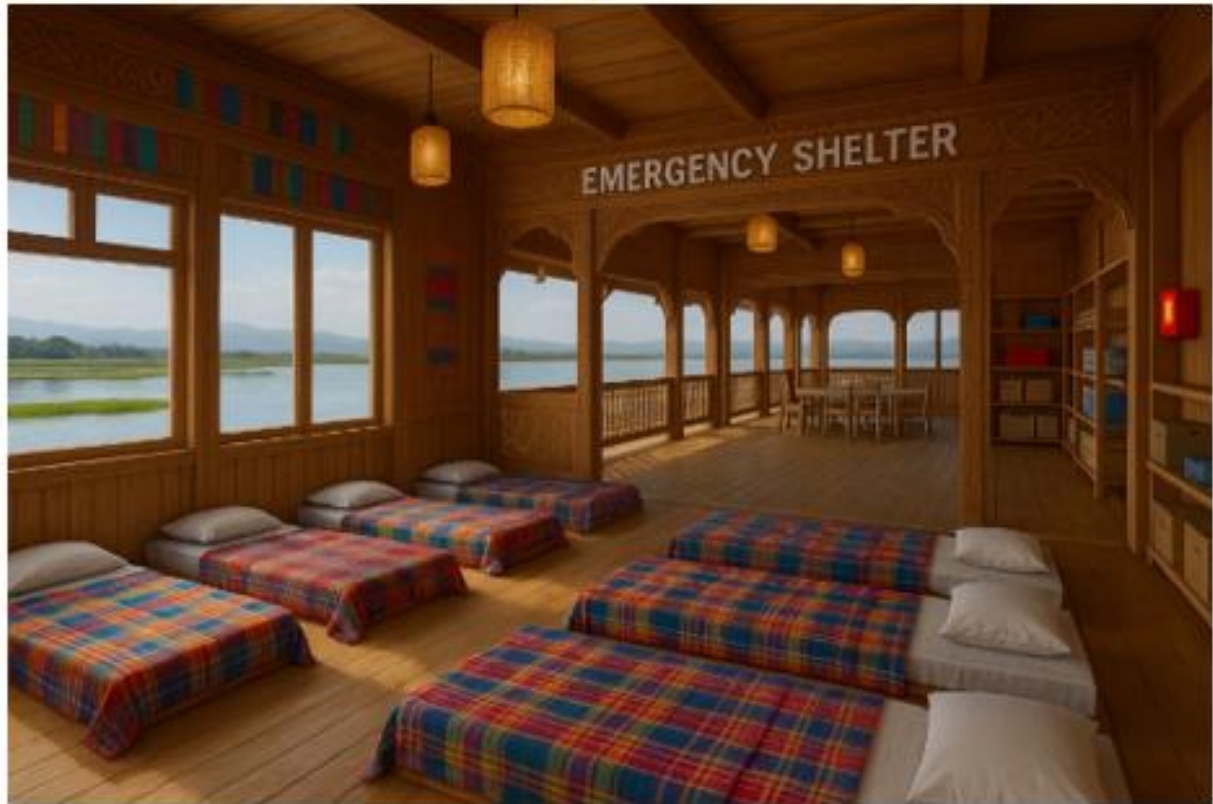
အတွင်းပိုင်းမြင်ကွင်း နမူနာ

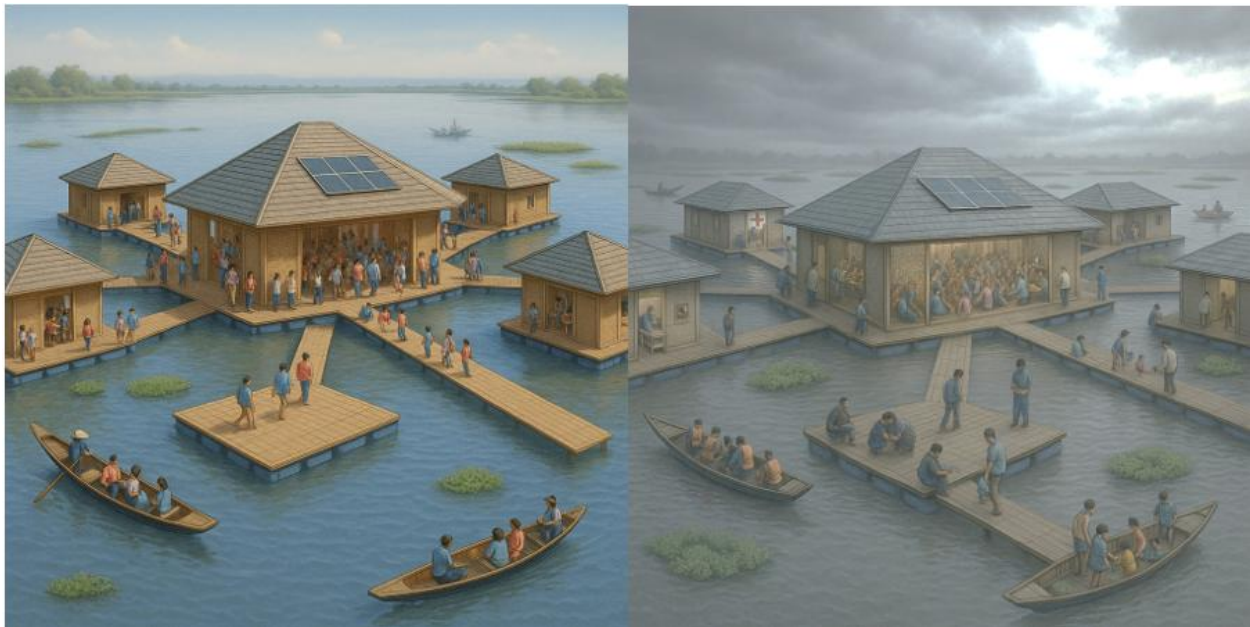
အဆောက်အဦများအား ရေပေါ်တံတားများဖြင့် လုပ်ငန်းလိုအပ်ချက်အတိုင်း လိုသလို တွဲဆက် ပြောင်းလဲ နိုင်ခြင်း (ပြန်လည်ထူထောင်ရေးစခန်း ၊ ယာယီဆေးရုံ ၊ ရေသန့်ဆောင် ၊ ချက်ပြုတ်ဆောင် ၊ မီးစက်ဆောင် ၊ ရေပေါ်ဈေး စသဖြင့်)

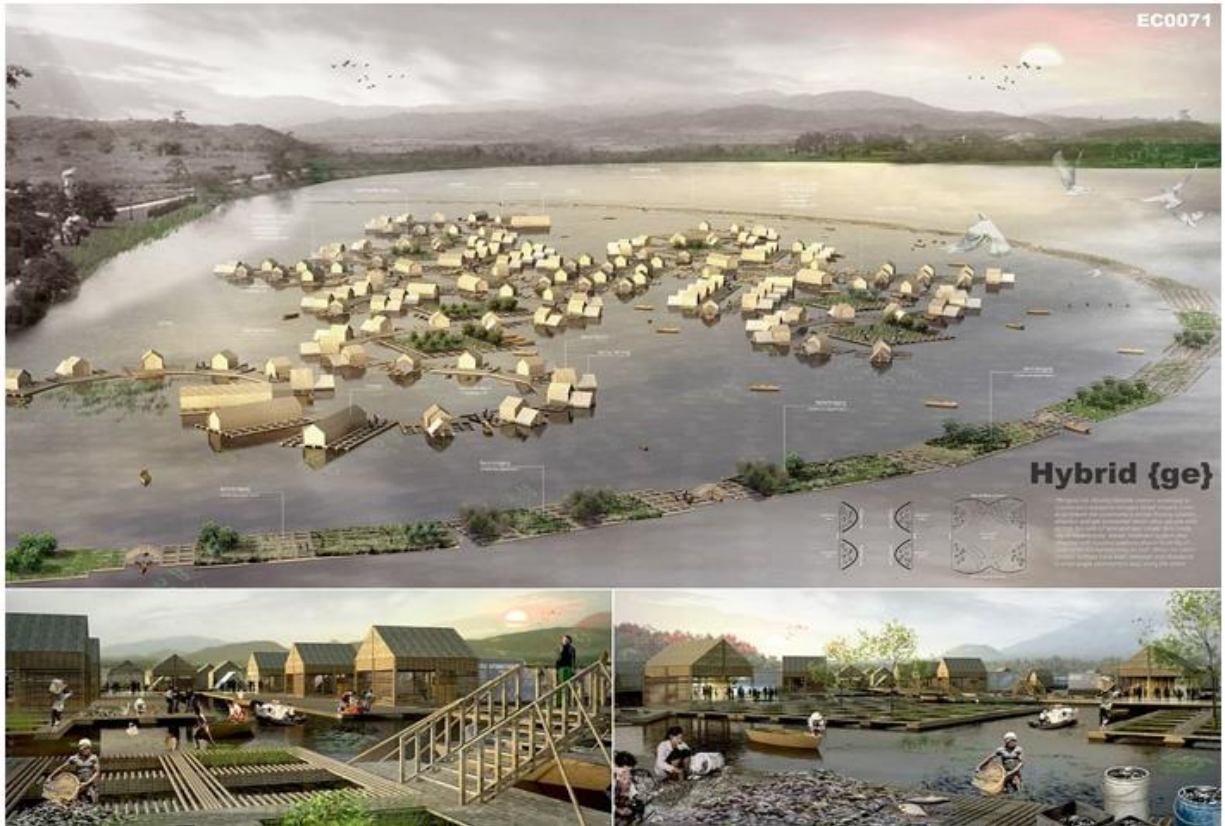
အင်းလေးကန်နှင့် သဘောသဘာဝတူညီသည့် ကမ္ဘောဒီးယားနိုင်ငံ ၊ တုံလေးဆပ်ရေကန်အတွက်
 ရေးဆွဲထားသော အချင်းချင်း ချိတ်ဆက်ထားသည့် ရေပေါ်ကျေးရွာ ဒီဇိုင်း တစ်ခု

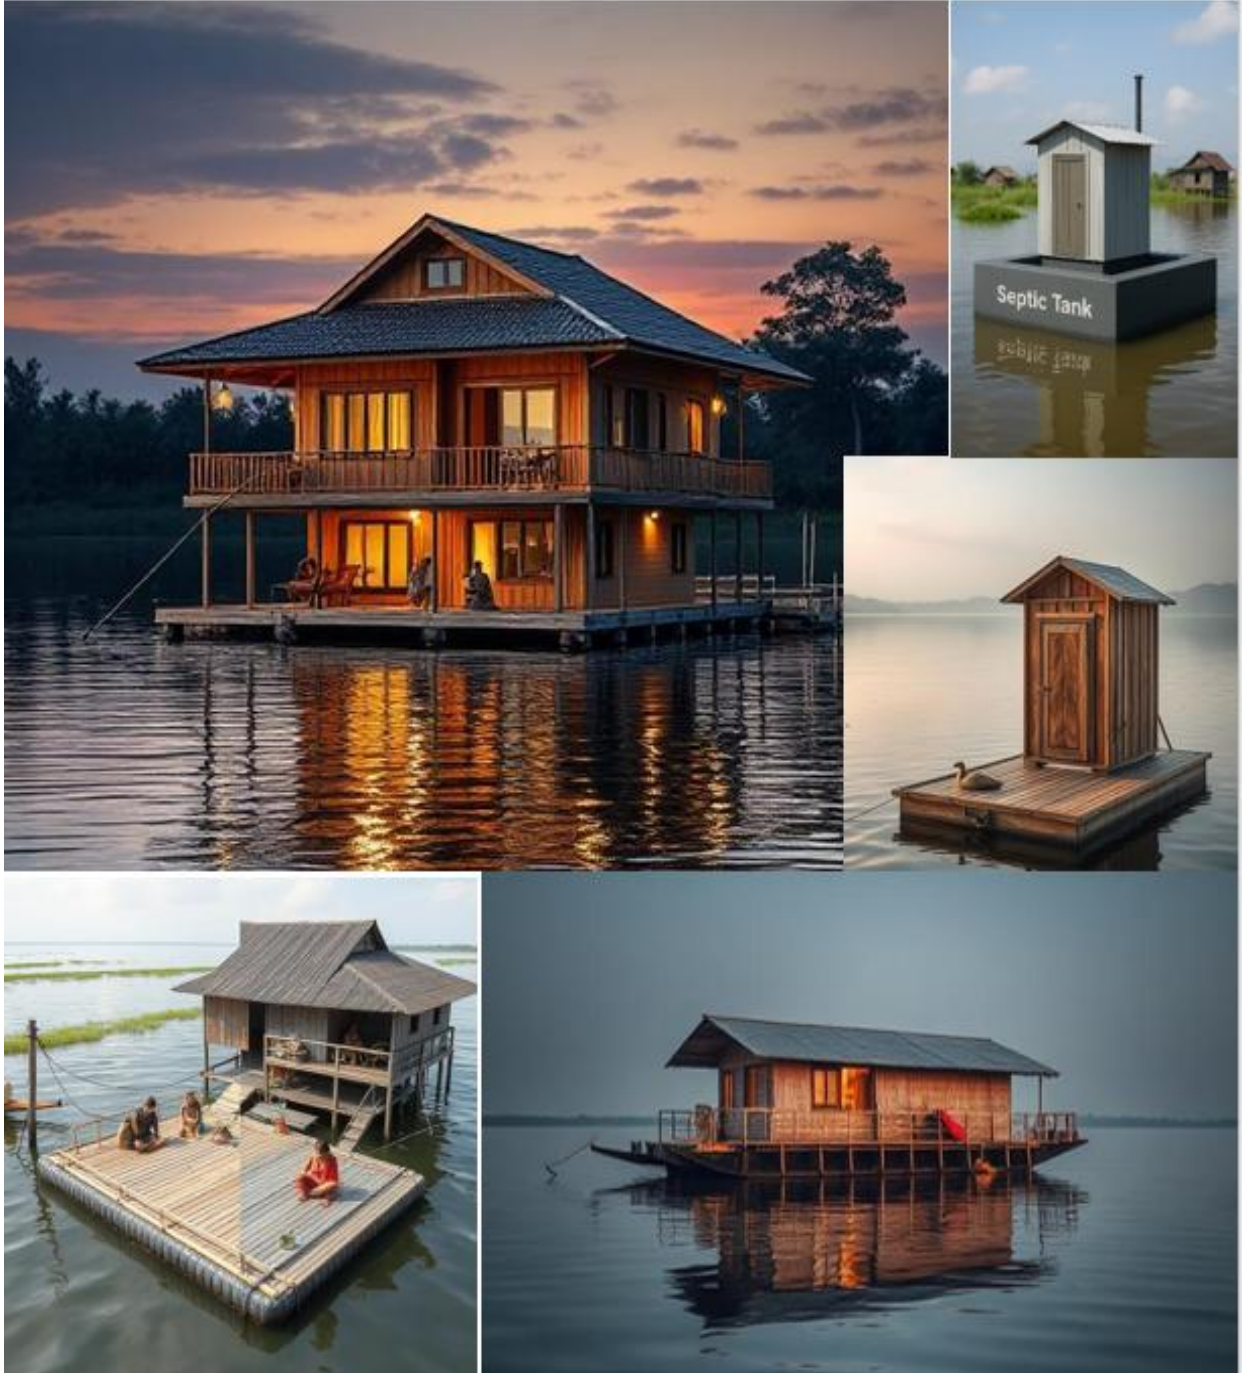
ရေအနိမ့်အမြင့်အတိုင်း လိုက်ပါရွေ့လျားနေမည့် ဖောင်သဘောတရား လူနေအိမ်များ ၊ စွယ်စုံသုံးဖောင်များ
 (ယာစောင့်တဲ ၊ ဇရပ် ၊ တံငါလုပ်ငန်းသုံး ၊ ဈေးဆိုင် ၊ လှေဆိပ် စသည်)

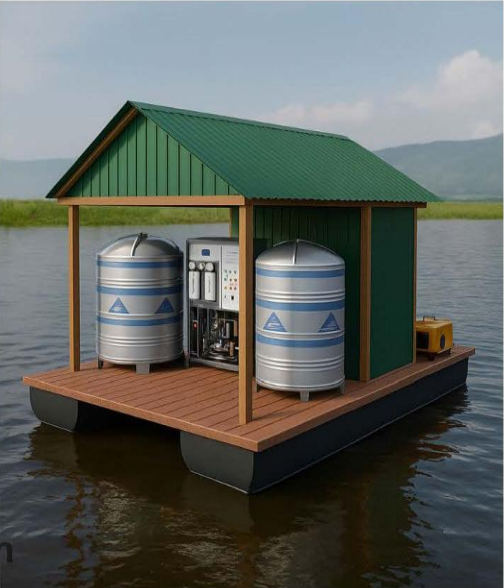
ရေပေါ်ရေသန့်ဆောင် နမူနာပုံစံ (Floating R.O Water Station)

ယခုအသုံးပြုနေသော ရေသန့်စနစ်များကို ရေပေါ်ဆောင် (Floating Station) တွင်ထားရှိခြင်းဖြင့် ရေကြီးသည့် အချိန်များတွင် ရေသန့်စနစ်ကို ရေလွှမ်းသည့်ဒဏ်များ ၊ ရေသန့်ထုတ်လုပ်ရာတွင် အခက်အခဲ တွေ့ခြင်းများကို ရှောင်ရှားနိုင်မည် ဖြစ်ပါသည်။ ဒေသခံလူထု၏ အခြေခံရေသန့်လိုအပ်ချက်ကို ဖြည့်ဆည်းရန် ထားရှိသည့် စနစ်ဖြစ်သောကြောင့် ရေသန့်စနစ်တစ်ခုလုံးကို ရေပေါ်ဆောင်ပေါ်တွင် ထားရှိတပ်ဆင်၍ တည်ထားခြင်းဖြင့် ရေဘေးကြုံတွေ့ချိန်တွင်ပါ ဆက်လက်လည်ပတ်နိုင်မည်ဖြစ်ပြီး အင်းလေးဒေသခံလူထု၏ အခြေခံရေသန့်လိုအပ်ချက်ကို စဉ်ဆက်မပြတ် ဆက်လက်ဖြည့်တင်း နေနိုင်မည် ဖြစ်ပါသည်။

ရေပေါ်ဆောင်မှာ ရွှေ့လျားနိုင်သည့်အတွက် လိုအပ်သည့်နေရာသို့ ရွှေ့ပြောင်းတည်ထားနိုင်သော အားသာချက်လည်း ရှိပါသည်။

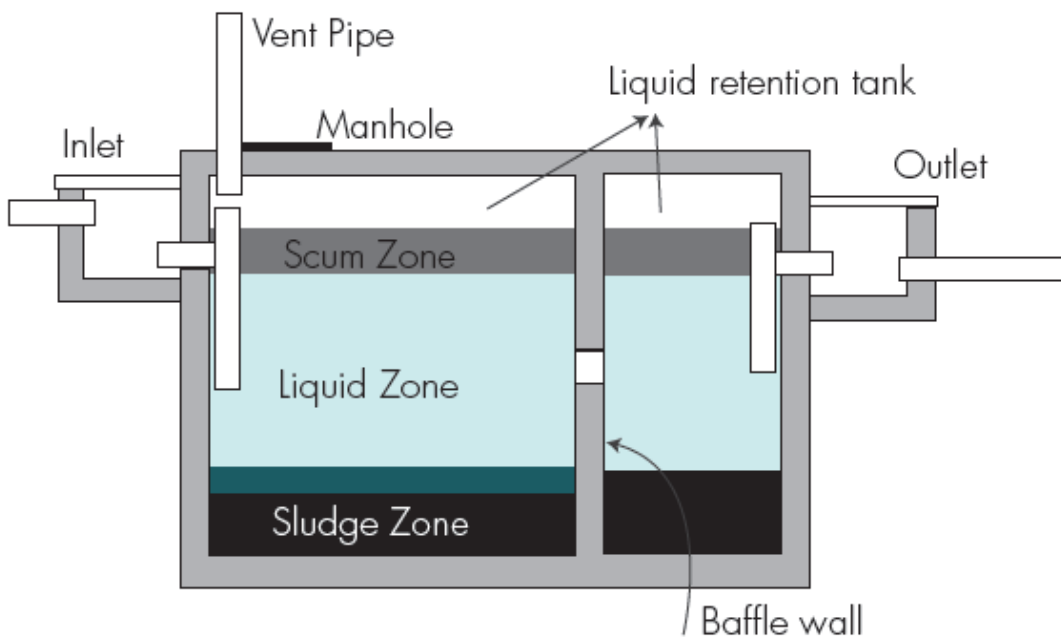
Key component of septic tank (Primary Treatment Unit)

In the primary treatment stage, which occurs inside the septic tank, wastewater enters the tank and undergoes a separation process. Solids settle at the bottom, forming sludge, while oil and grease float to the top as scum. The clearer liquid, known as effluent, remains in the middle layer. During this stage, anaerobic bacteria microorganisms that thrive without oxygen begin breaking down the organic matter in the wastewater. However, the effluent that exits the septic tank still contains pathogens, nutrients such as nitrogen and phosphorus, and some remaining organic material, making further treatment necessary before it can be safely reused or discharged.

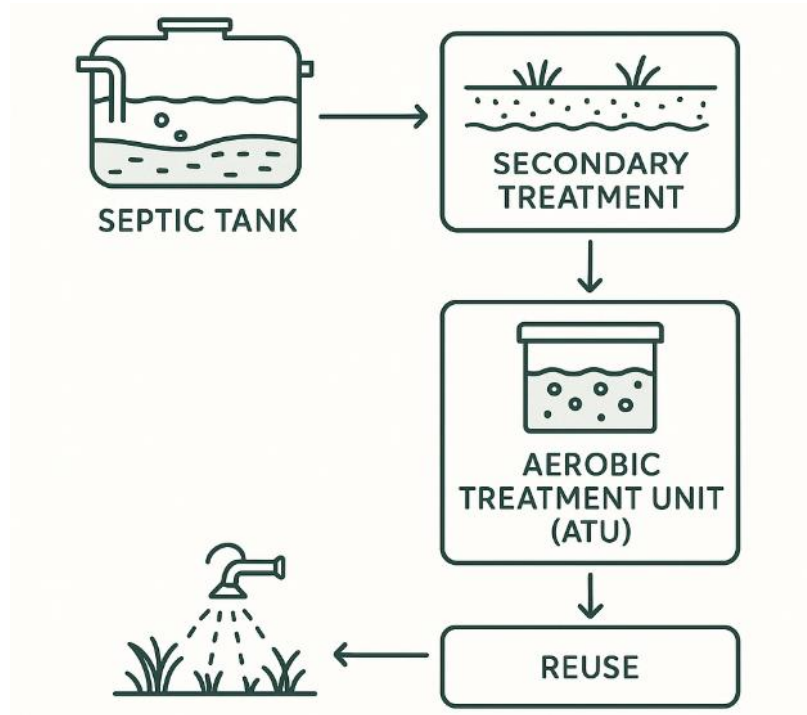
Septic tank effluent/liquid waste treatment and reuse at non-potable use

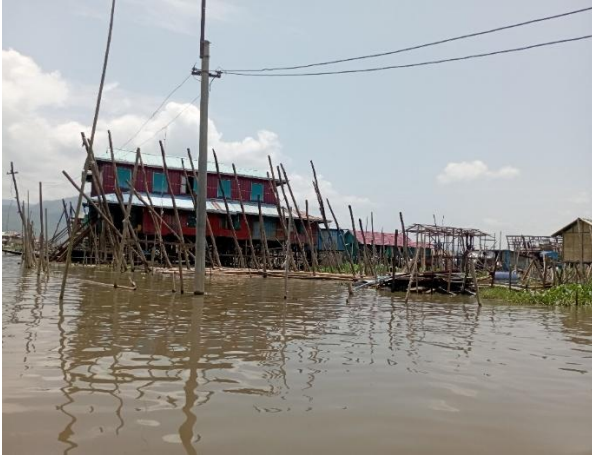
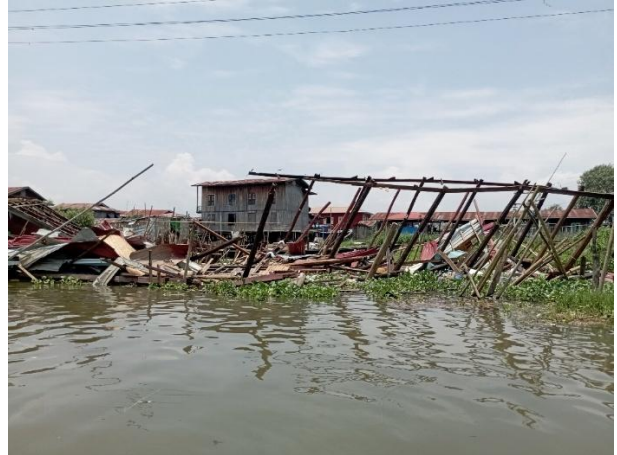
ငလျင်ကြောင့်ပျက်စီးသွားသည့် အဆောက်အဦများမှ ကျန်ရစ်သည့် အိမ်အောက်ခြေ သစ်သားတိုင်များ

ကျွန်တော်တို့ White Swan Boating အဖွဲ့မှ ၁၂.၅.၂၀၂၅ နေ့တွင် အင်းလေးဒေသသို့ ကွင်းဆင်း လေ့လာမှုများအရ ငလျင်သင့် ပျက်စီး အိမ်များ၏ အိမ်အောက်ခြေတိုင်များကို ပြန်လည်ဆွဲနုတ် ဖယ်ရှားရန်အတွက် လုပ်ငန်းသုံး ဖောင်များ လိုအပ်လျက်ရှိသည်ကို သိရှိခဲ့ရပါသည်။

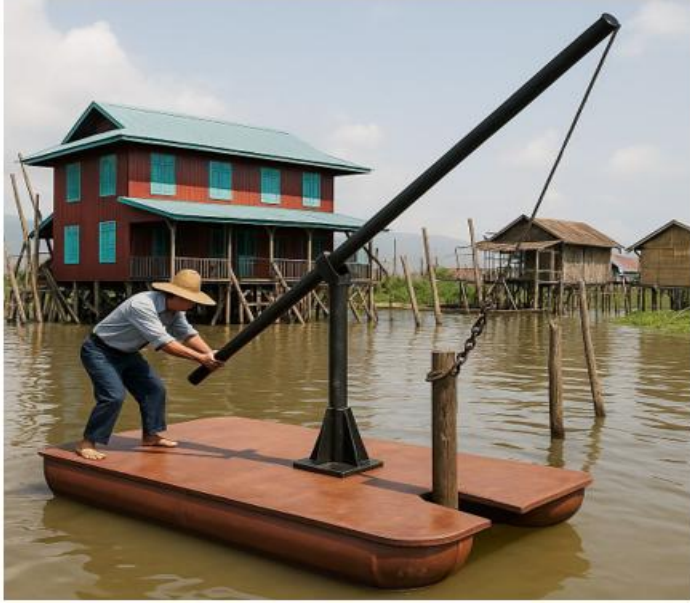
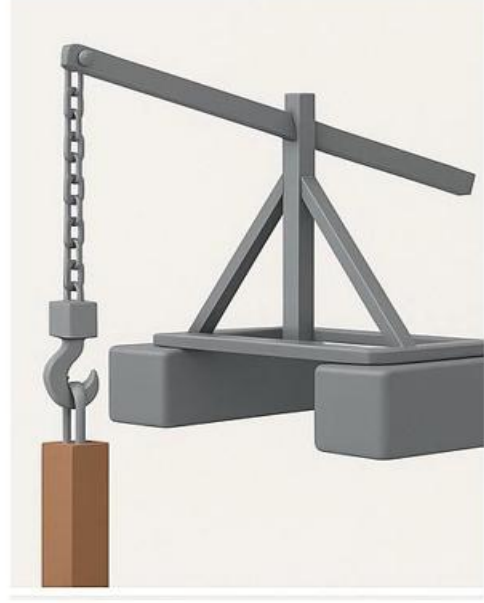
ကုတ်သဘောတရားအသုံးပြုခြင်း ပုံစံ (သဘောတရားပြပုံ)

၃။ ယခုအသုံးပြုလျက်ရှိသည့် ချိန်းဘလောက်ဆွဲတင်နည်းအတိုင်းအသုံးပြုရန်အတွက် သင့်လျော်သည့် ကိုင်းတန်း (Gantry Frame) နှင့် ရေပင့်အား ဖန်တီးပေးခြင်း

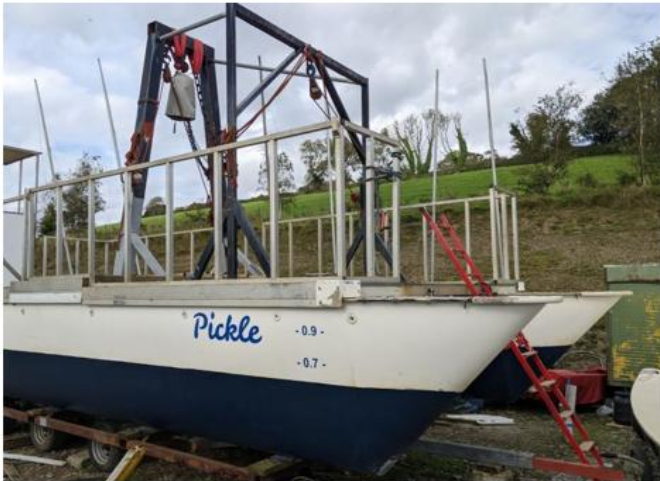
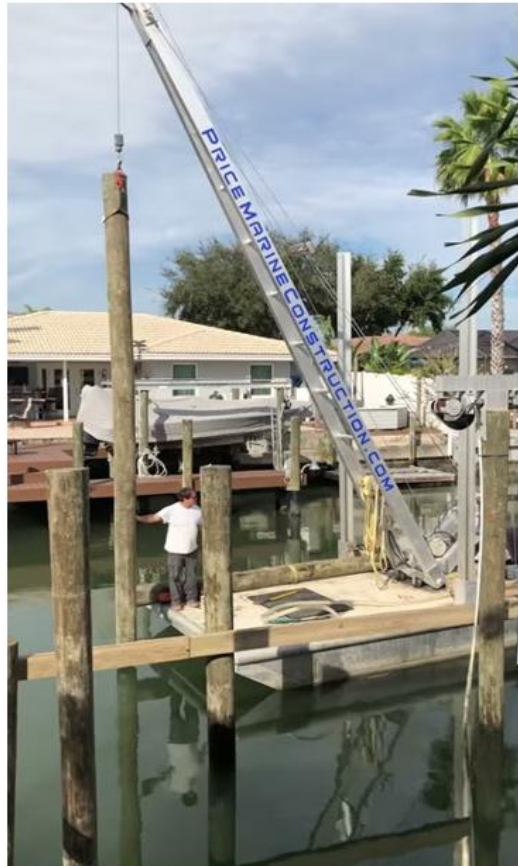
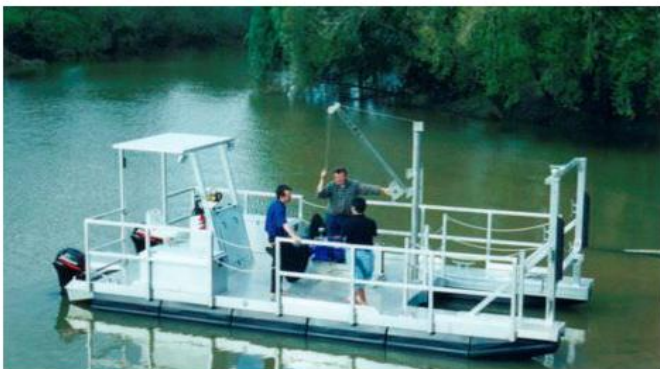
ဝန်ချိစက် ၊ ချိန်းဘလောက် ၊ ကရိန်းစသည့် ကိရိယာများတပ်ဆင်ထားသည့် လှုပ်ငန်းသုံး
ရေယာဉ်အမျိုးအစားများ
