# Monitoring & Evaluation (M&E) Assessment Report

## Inle Lake Post-Disaster Environmental Assessment and Rehabilitation Plan

(December 2025)

## Myanmar Environmental and Sustainable Development Initiative (MESDI)

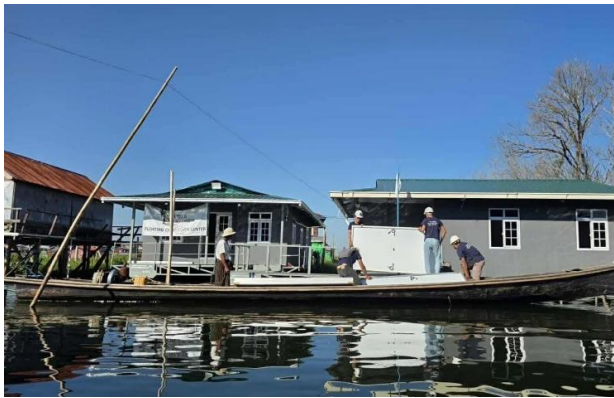
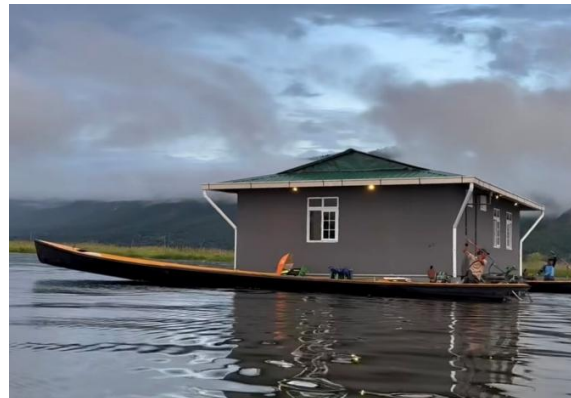
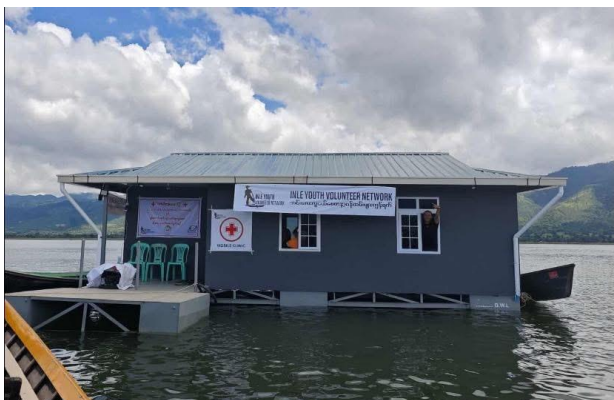
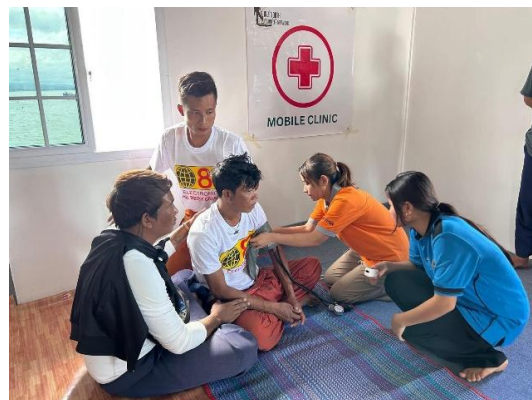
**Figure 2-1 Disaster Risk Reduction and Community Engagement**

As part of community-led disaster preparedness initiatives, two Floating Disaster-Resilient Shelters with integrated sanitation facilities have been established and are currently under operation by the Inle Youth Volunteer Network (IYVN). These floating shelters were financed

through contributions from local donors and constructed by a local contractor, reflecting strong community participation and local ownership. The facilities are strategically located at Nampan (Ye Ale) Village and are designed to serve multiple functions, including emergency shelter during disaster events as well as a meeting venue and community center during normal periods. Currently, the shelters are actively utilized by IYVN for community meetings, mobile clinic during the festive days, women and youth-led initiatives, demonstrating a practical and context-appropriate model for multipurpose, disaster-resilient infrastructure in the Inle Lake.

Two Floating shelters stationed at Nampan (Ye Ale) Village

Floating shelter on the move

Floating shelter used as a mobile clinic

Inside a floating shelter used as a mobile clinic

If Inle Lake Rehabilitation Authority (ILRA) had been established and operational, it could have played a pivotal role in scaling up and institutionalizing large, multipurpose floating disaster-resilient shelters in the Inle Lake area. With a clear legal mandate, technical authority, and coordinated financing mechanisms, it could have supported to develop larger floating facilities equipped with adequate water supply and sanitation systems, capable of supporting evacuation, temporary accommodation, and emergency response during disaster periods. Under normal conditions, these facilities could have been systematically managed and commercially operated as tourist resting and sightseeing platforms, venues for wedding ceremonies, conference and training halls, and spaces for cultural exhibitions and traditional dance performances. Importantly, such diversified use would enable ILRA to generate sustainable revenue streams, which could be transparently reinvested into lake conservation,

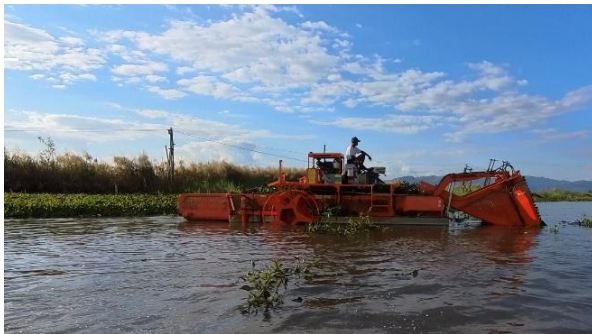
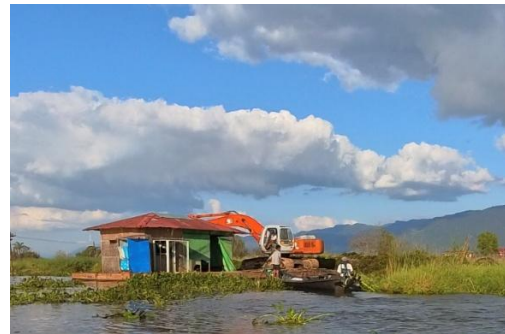
**Figure 2-2 Hyacinth clearing and Dredging work in Nga Phal Chaung, Inle 16 November 2025**

Current approach to sediment dredging and water hyacinth clearing in Inle Lake remains mainly reactive, leading to inefficient resource use and compromised waterway functionality. Maintenance is often delayed until navigational channels are critically obstructed or scheduled only in anticipation of high-profile events such as the Inle's Phaung Daw Oo festival. This practice results in emergency-style operations, higher long-term costs, and fails to address the continuous ecological stress caused by siltation and invasive species proliferation. To maintain

Hyacinth clearing in Nga Phal Chaung, Inle  
16 November 2025

Dredging work in Nga Phal Chaung, Inle  
16 November 2025

lake health and accessibility, a year-round maintenance approach is necessary. This requires the dedicated procurement and deployment of appropriate Dredging Equipment and Water Hyacinth Clearing Equipment, supported by a planned maintenance schedule and dedicated operational budget. Implementing a program of Regular Dredging and Regular Maintenance Clearing throughout the year will prevent acute blockages, improve water flow and quality consistently, and is a more cost-effective and ecologically sound strategy than repeated crisis intervention.

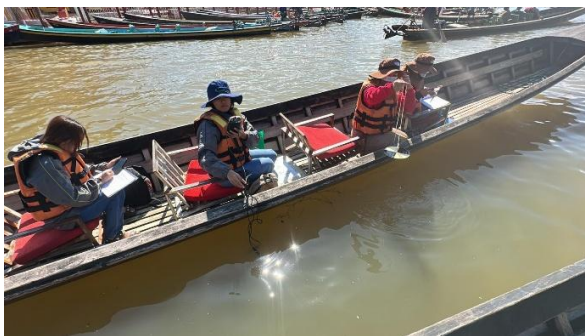
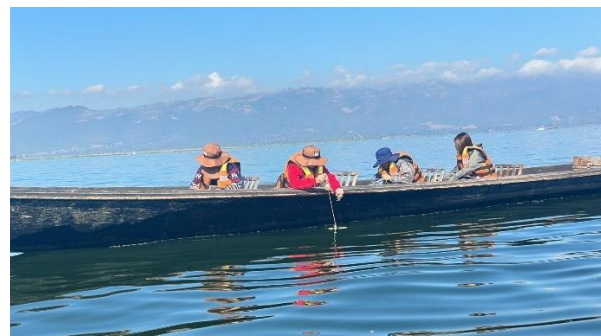
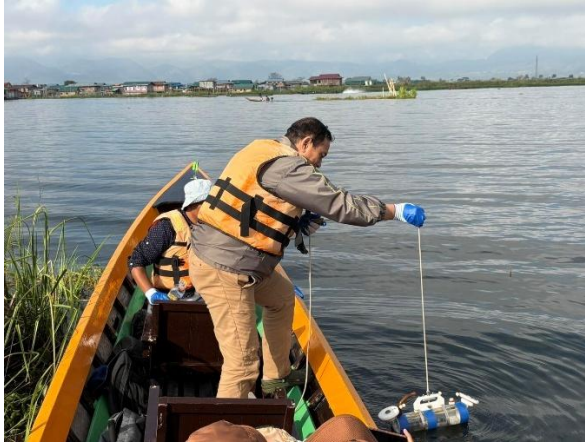
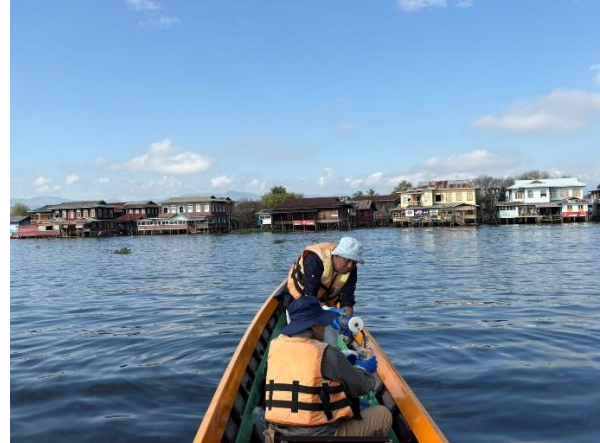
### **Figure 2-6 On-site Water Quality Measurement and Sampling**

On-site Water Quality Measurement near Phaung Daw Oo Pagoda

On-site Water Quality Measurement in the mid location of the lake

On-site water sampling using Niskin Sampler

On-site water sampling near the out let of Inle Lake, downstream of NamPan Ye Ale Village

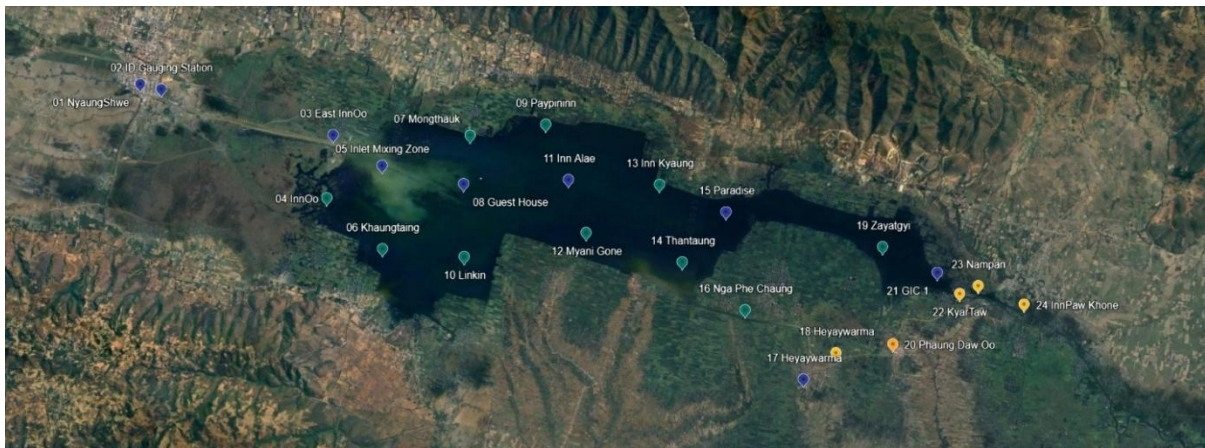
**Figure 2-7 Proposed sampling locations for water quality monitoring**

**Monitoring Methodology:** The most modern and effective method involves installing automatic monitoring buoys/stations at various points across the lake, transmitting data in real-time via radio or mobile networks to a central office. However, methods suitable for Myanmar's current context must be employed. Therefore, it is first necessary to strategically define traditional water sampling points and parameters. A monitoring plan must be developed based on available funding and human resources. Below is the proposed sampling locations of monitoring points selected for long term water quality monitoring of Inle Lake.

Establishment of continuous water quality monitoring is essential for the effective management and long-term sustainability of Inle Lake, as it enables the accurate identification of pollution sources and types, thereby supporting targeted prevention and control measures.
